CONSTRUCTION EQUIPMENT

VOLVO L110H 631237 - TRANSMISSION (AUTO)

Sample No: VCP441514

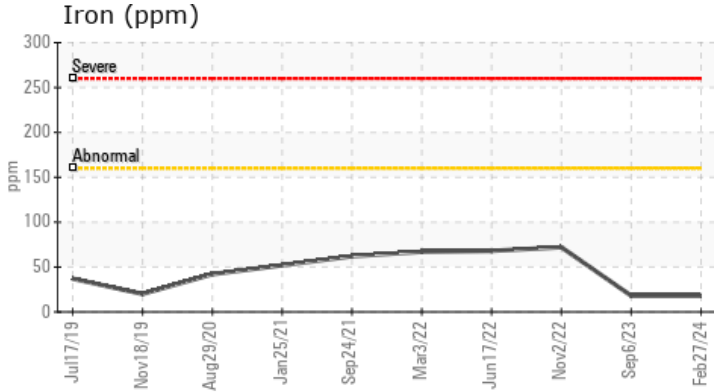
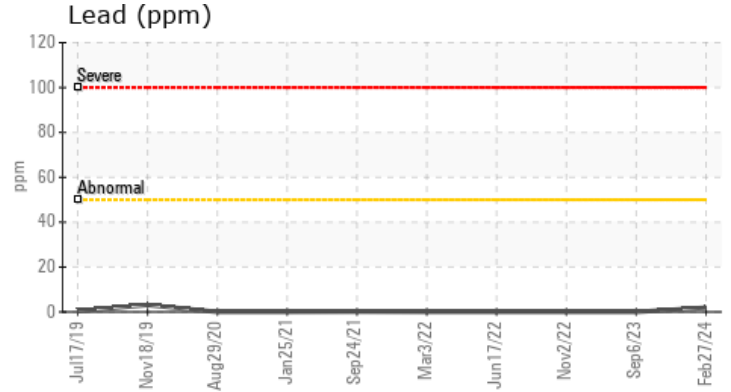
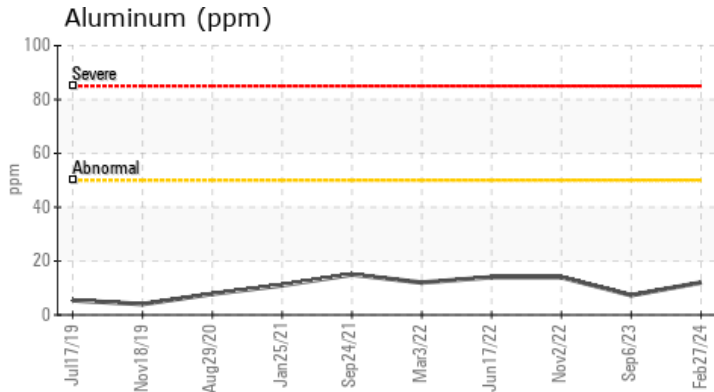
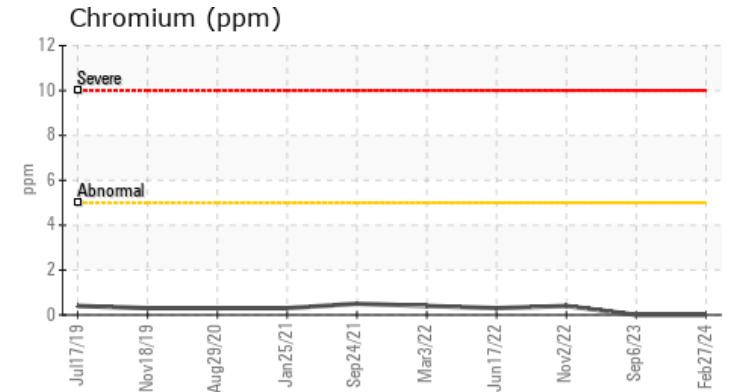
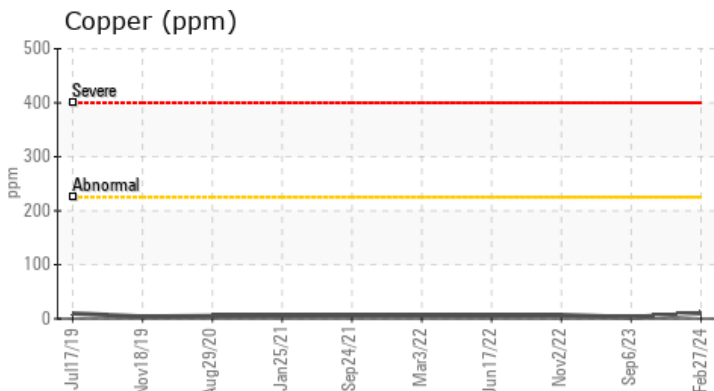
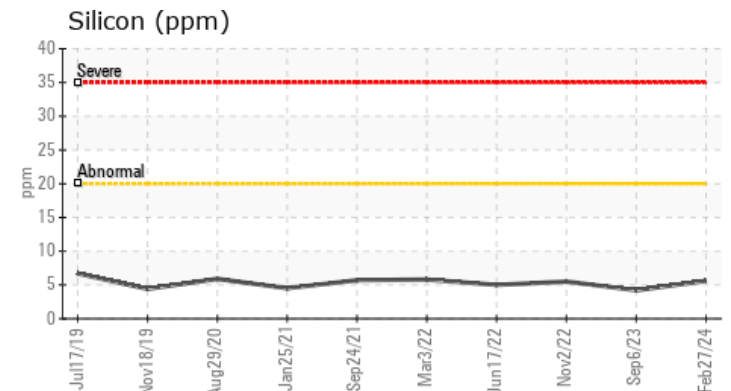
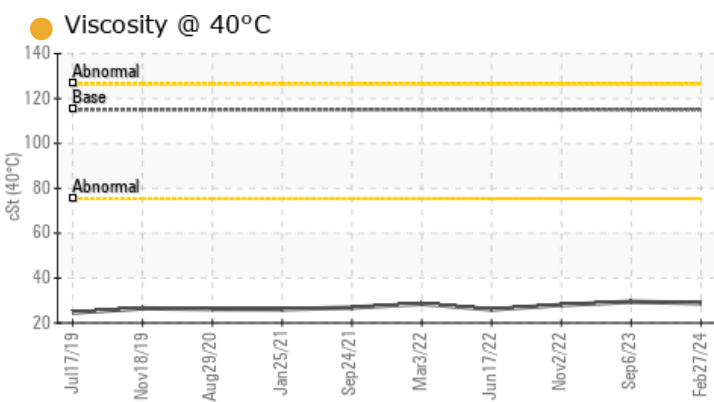
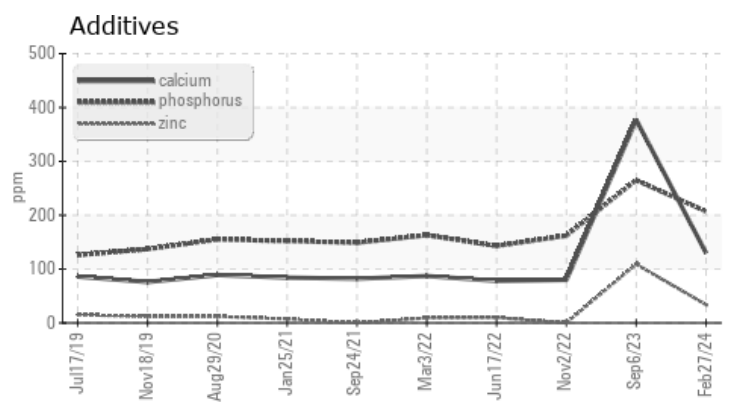
GRAPHS

Resample at the next service interval to monitor. All component wear rates are normal. There is no indication of any contamination in the fluid. The fluid viscosity is lower than normal. Additive levels indicate the addition of a different brand, or type of fluid. Confirm oil type.
