SVC53073 MORRONE EXC VOLVO EC160BLC 11381 - HYDRAULIC SYSTEM

Sample No: VCP407147
Oil Type: AW 42
Job No: SVC53073 MORRONE EXC

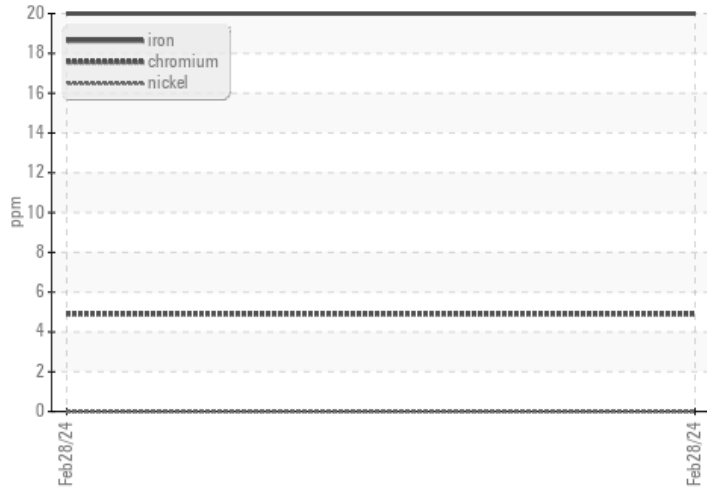
Ferrous Alloys

Iron	ppm	█ 20	---	---	---
Copper	ppm	█ 15	---	---	---
Lead	ppm	█ 0	---	---	---
Tin	ppm	█ 0	---	---	---
Aluminum	ppm	█ <1	---	---	---
Chromium	ppm	█ 5	---	---	---
Molybdenum	ppm	█ 0	---	---	---
Nickel	ppm	█ 0	---	---	---
Titanium	ppm	█ 0	---	---	---
Silver	ppm	█ 0	---	---	---
Manganese	ppm	█ 0	---	---	---
Vanadium	ppm	█ 0	---	---	---

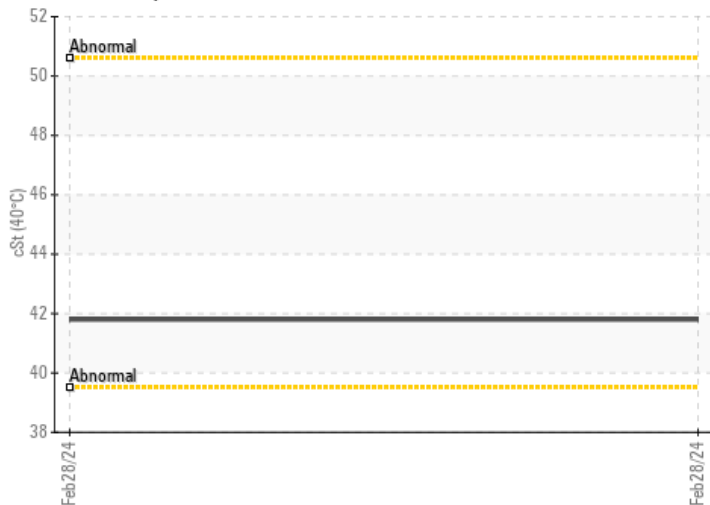
Viscosity @ 40°C

Visc @ 40°C	cSt	█ 41.8	---	---	---
Acid Number (AN)	mg KOH/g	█ 0.43	---	---	---

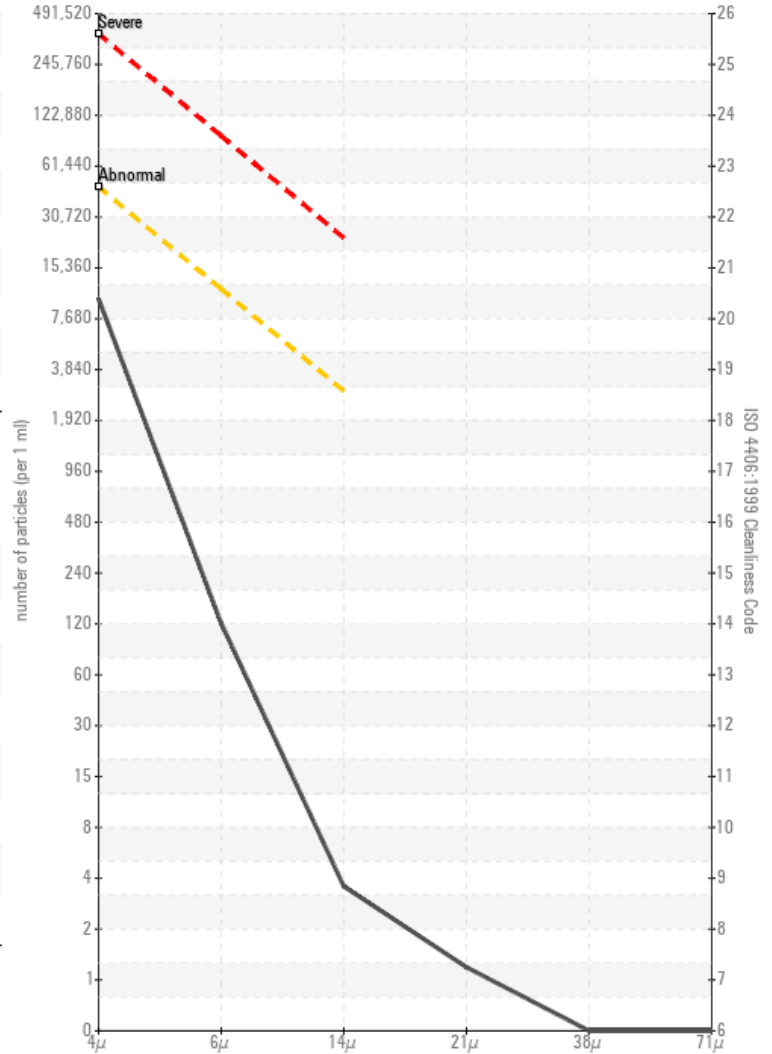
Particle Count

Water	%	NEG	---	---	---
Particles >4µm		█ 8773	---	---	---
Particles >6µm		█ 107	---	---	---
Particles >14µm		█ 3	---	---	---
ISO 4406:1999 (c)		20/14/9	---	---	---
Silicon	ppm	█ 3	---	---	---
Sodium	ppm	█ 1	---	---	---
Potassium	ppm	█ 0	---	---	---
