# CONSTRUCTION EQUIPMENT

## A12259 VOLVO L110H 632555 - DIESEL ENGINE

**Sample No:** VCP407248  
**Oil Type:** MOBIL 15W40  
**Job No:** A12259

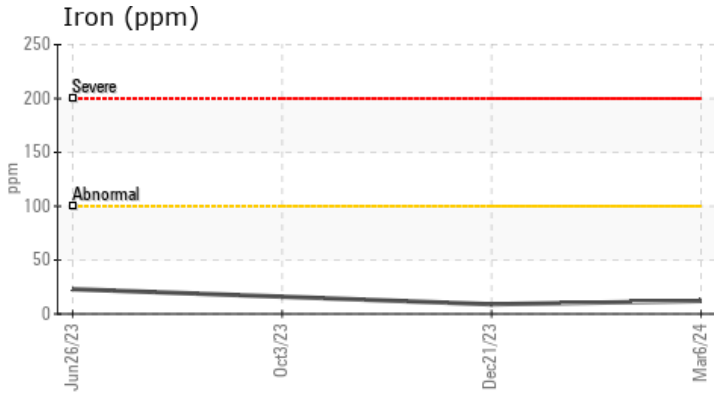
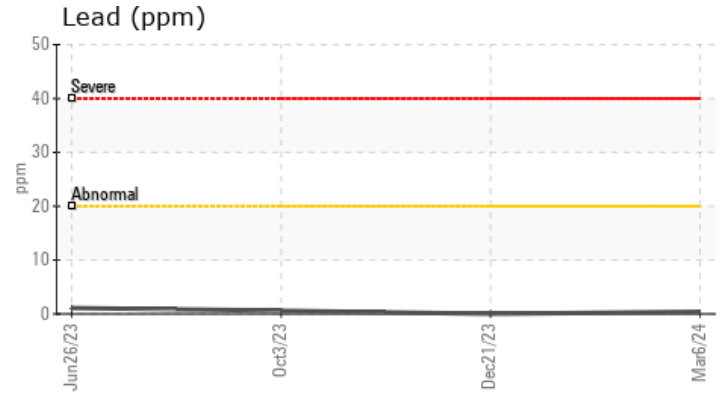
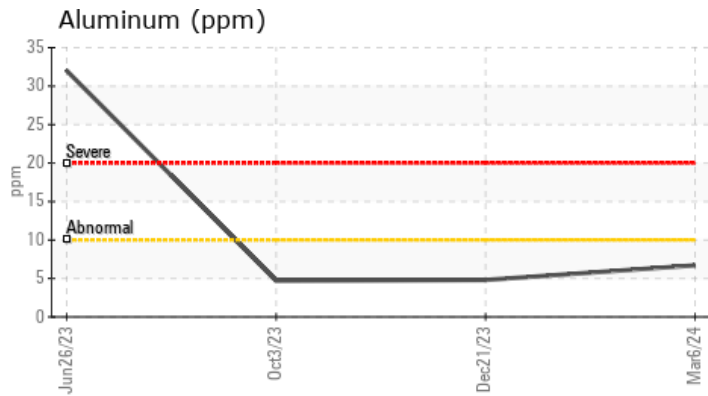
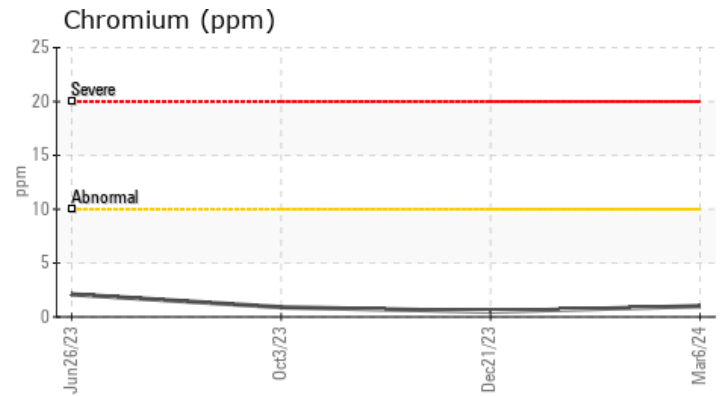
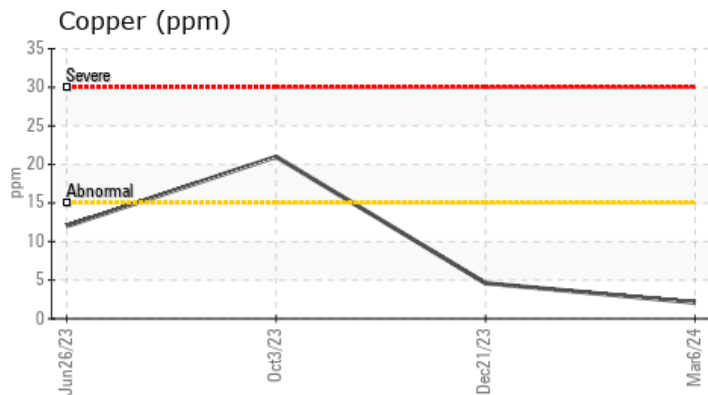
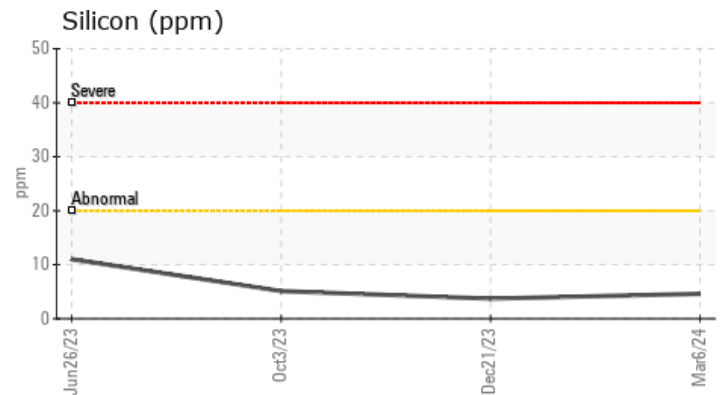
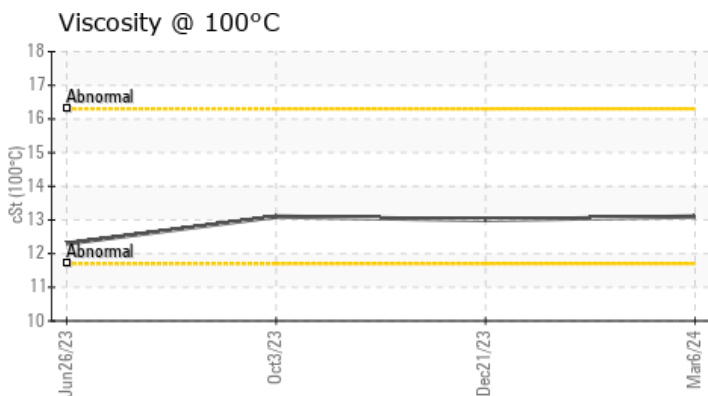
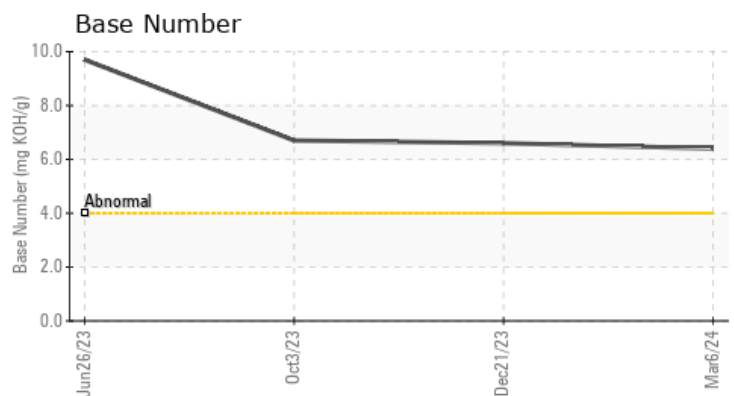
## GRAPHS

Resample at the next service interval to monitor. All component wear rates are normal. There is no indication of any contamination in the oil. The BN result indicates that there is suitable alkalinity remaining in the oil. The condition of the oil is suitable for further service.
