# CONSTRUCTION EQUIPMENT

## 687121 APTIM VOLVO A35G 340236 - REAR AXLE

**Sample No:** VCP444170  
**Oil Type:** VOLVO PREMIUM GEAR OIL 80W-90 GL-5  
**Job No:** 687121 APTIM

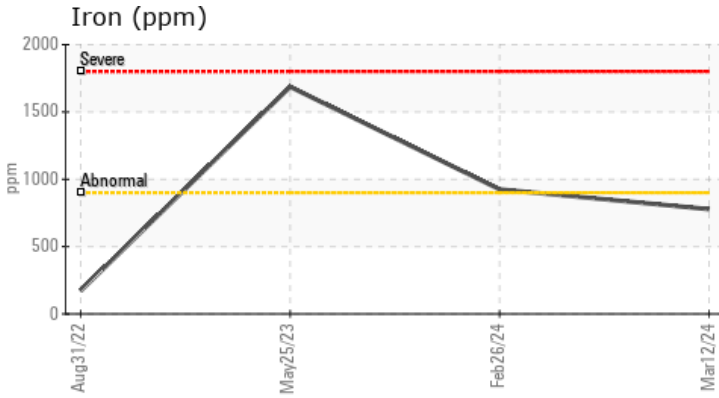
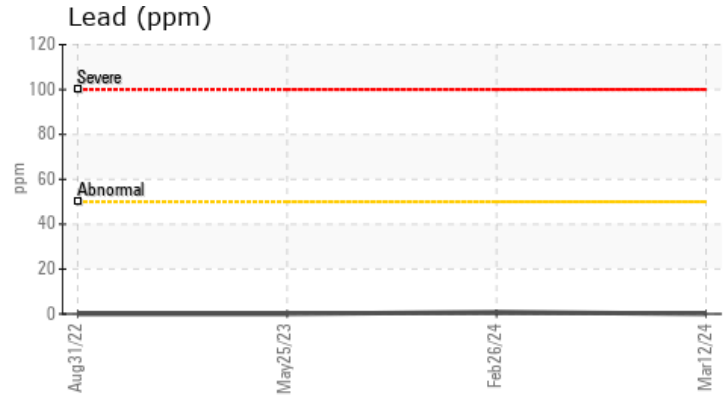
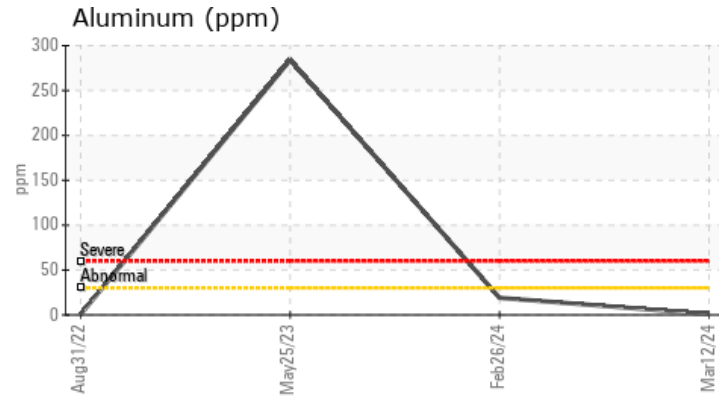
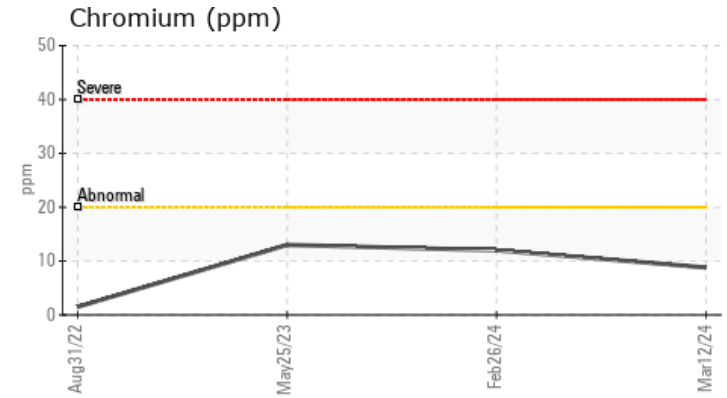
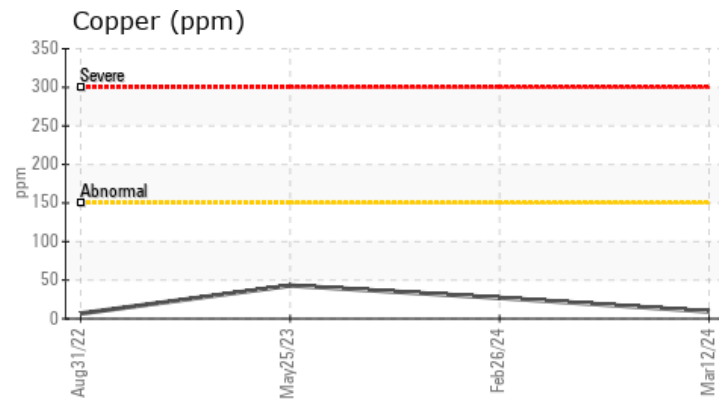
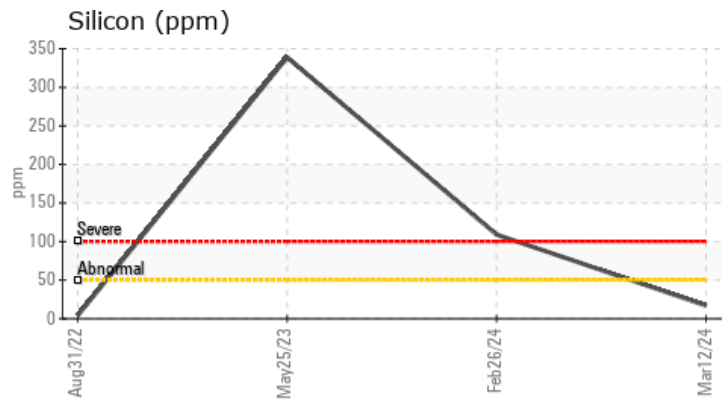
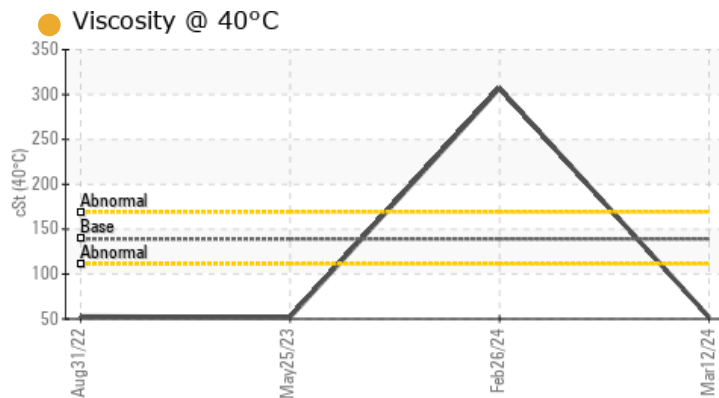
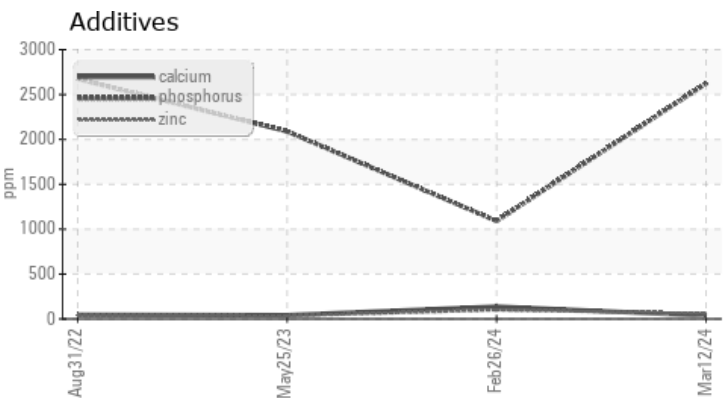
## GRAPHS

Resample at the next service interval to monitor. All component wear rates are normal. There is no indication of any contamination in the oil. The oil viscosity is lower than normal. Confirm oil type.
