CONSTRUCTION EQUIPMENT

VOLVO L220H 2818 - TRANSMISSION (AUTO)

Sample No: VCP452212

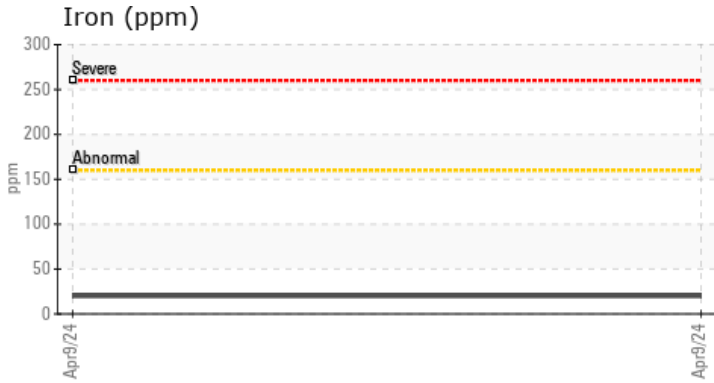
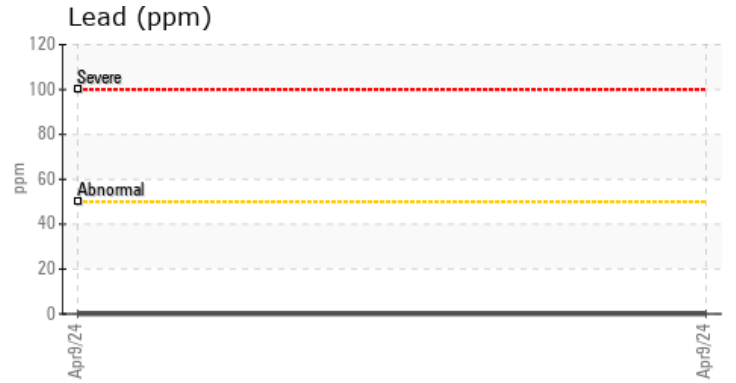
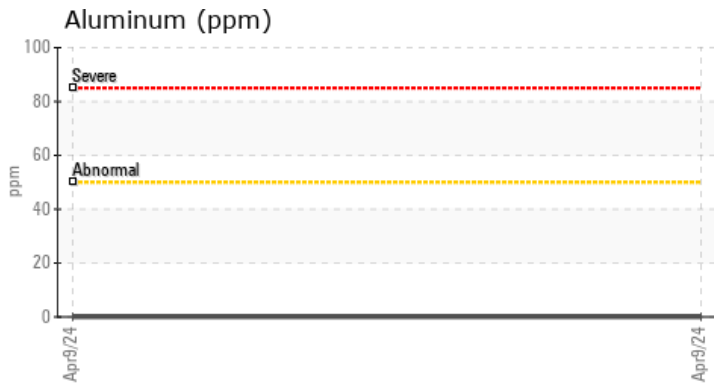
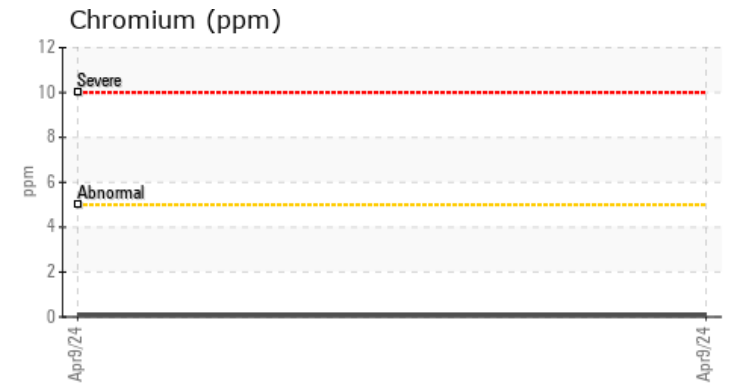
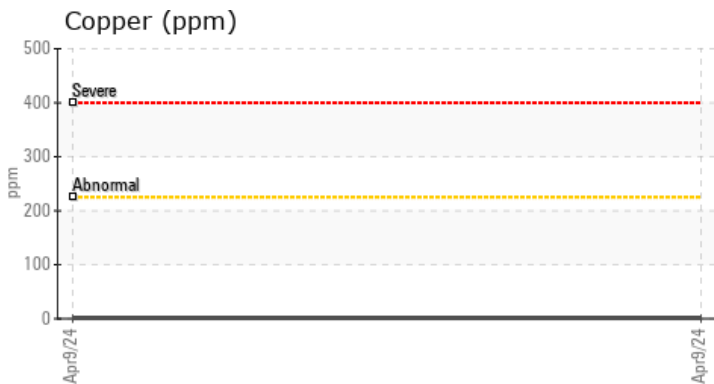
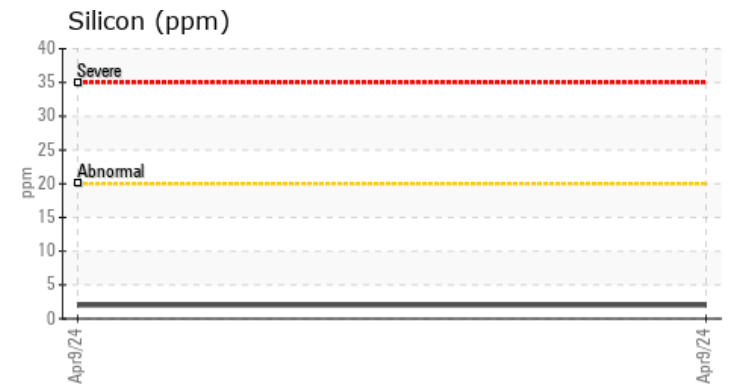
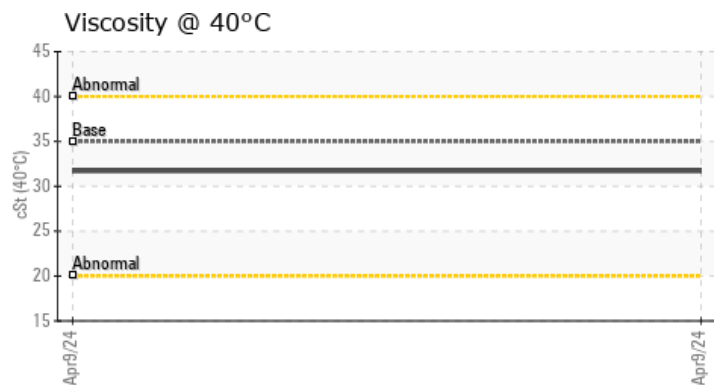
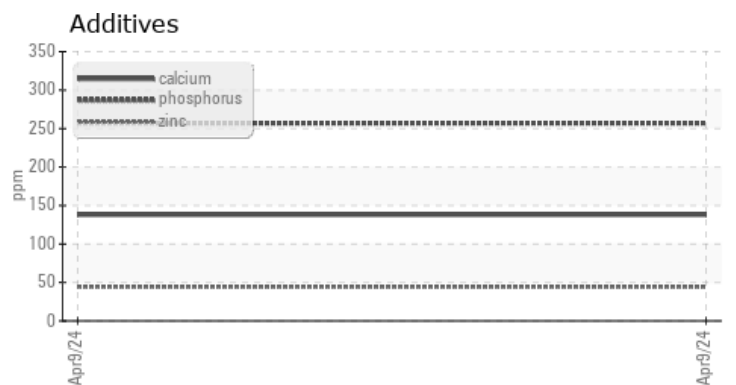
VOLVO GRAPHS

Resample at the next service interval to monitor. The fluid was not specified, however, a fluid match indicates that this fluid is (GENERIC) DEXRON III. Please confirm. All component wear rates are normal. There is no indication of any contamination in the fluid. The condition of the fluid is acceptable for the time in service.
