CONSTRUCTION EQUIPMENT

701243 HERC VOLVO L70H 625244 - TRANSMISSION (AUTO)

Sample No: VCP443726
Oil Type: VOLVO AUTOMATIC TRANSMISSION FLUID AT102
Job No: 701243 HERC

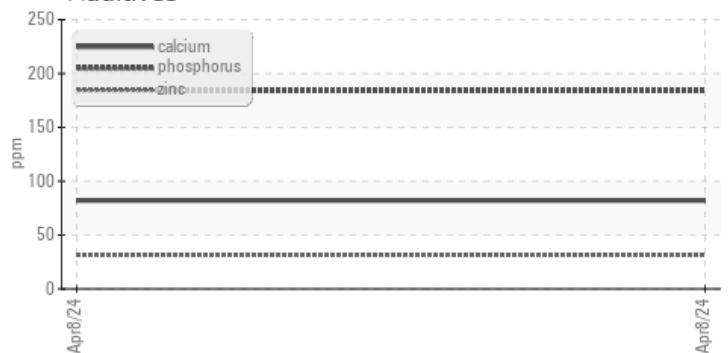
Additives

Calcium	ppm	82	---	---	---
Magnesium	ppm	█ 3	---	---	---
Zinc	ppm	█ 31	---	---	---
Phosphorus	ppm	█ 184	---	---	---
Barium	ppm	█ 6	---	---	---
Boron	ppm	█ 81	---	---	---
