702244 RENTAL VOLVO A30G 753626 - HYDRAULIC SYSTEM

Sample No: VCP451306
Oil Type: VOLVO SUPER HYDRAULIC OIL 46
Job No: 702244 RENTAL

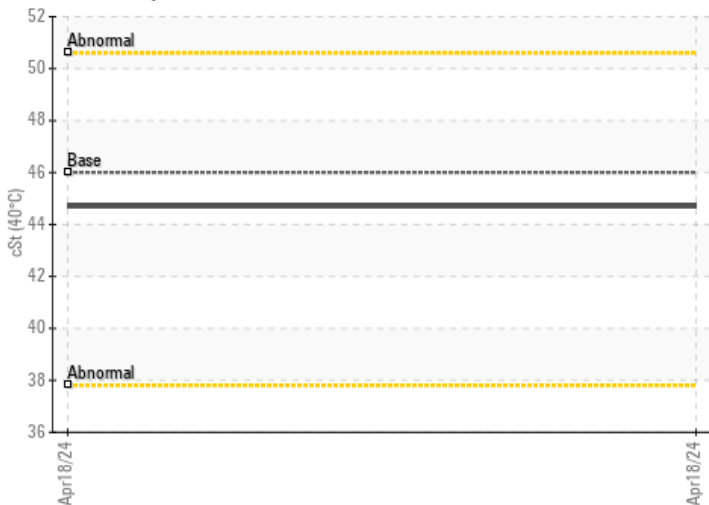
Viscosity @ 40°C

Visc @ 40°C	cSt	█ 44.7	---	---	---
Acid Number (AN)	mg KOH/g	█ 0.52	---	---	---
