CONSTRUCTION EQUIPMENT W114063091 CAROLINA VOLVO A45G 342225 - TRANSMISSION (A

Sample No: VCP369878

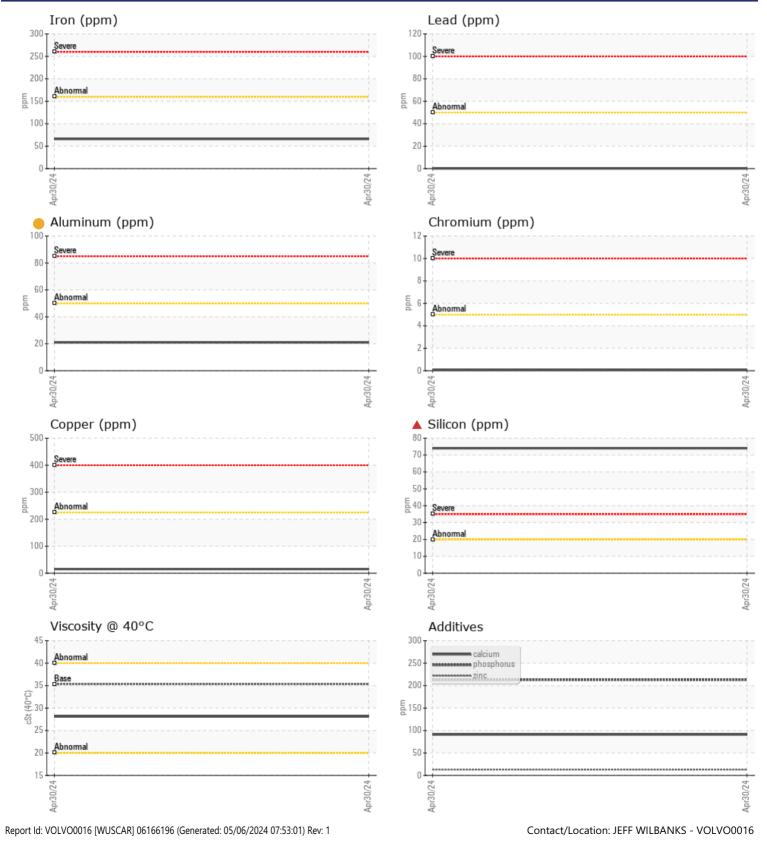
GRAPHS

E INFORMATION	l			
Sample Number	-	VCP369878	 		
Sample Date		30 Apr 2024	 		114 - ASCENDUM MACHINERY INC - CONCORD
Machine Hours		7225	 		1025 INTERNATIONAL DR NW
Oil Hours		1240	 		CONCORD, NC
Oil Changed		Not Changd	 		US 28027
Sample Status		SEVERE	 		Contact: JEFF WILBANKS
					jeff.wilbanks@ascendummachinery.com
OIL CON					T: (704)599-8179
		<u>.</u>	 <u>.</u>	<u>.</u>	F: (704)596-1362
Visc @ 40°C	cSt	28.1	 		
VOLVO					Diagnosis
CONTAI	MINATION				
Water	%	NEG	 		We advise that you check all areas
Silicon	ppm	▲ 74	 		where dirt can enter the system. We recommend that you drain the fluid
Sodium	ppm	3	 		from the component if this has not
Potassium	ppm	3	 		already been done. We recommend
Totassium	ppm				an early resample to monitor this
VOLVO	METALS				condition.All component wear rates are normal. Elemental levels of silicon
WEAR I	METALS				(Si) and aluminum (Al) indicate
Iron	ppm	66	 		alumina-silicate (coarse dirt) ingress.

Copper	ppm	15	 		The fluid is no longer serviceable due
Lead	ppm	■ <1	 		to the presence of contaminants.
Tin	ppm	■4	 		
Aluminum	ppm	21	 		
Chromium	ppm	■ <1	 		
Molybdenum	ppm	 <1	 		
Nickel	ppm	2	 		
Titanium	ppm	<1	 		
Silver	ppm		 		
Manganese	ppm	2	 		
Vanadium	ppm	<1	 		
ADDITI	VES				
Calcium	ppm	91	 		
Magnesium	ppm	2
