# CONSTRUCTION EQUIPMENT

## VOLVO A40G 752 153 - TRANSMISSION (AUTO)

**Sample No:** VCP440419  
**Oil Type:** VOLVO AUTOMATIC TRANSMISSION FLUID AT102  
**Job No:**

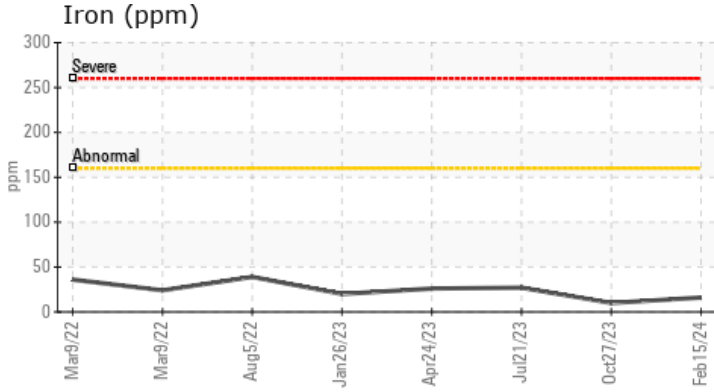
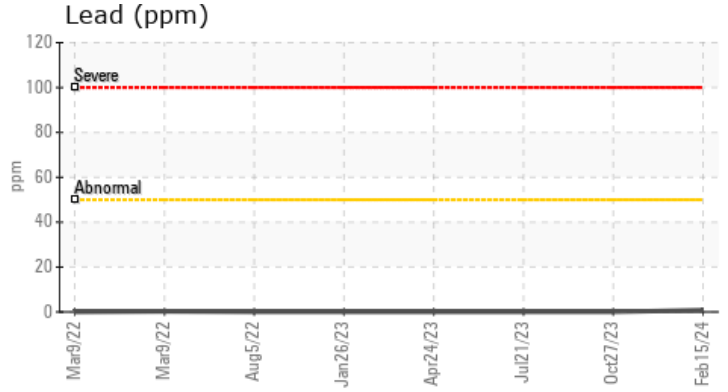
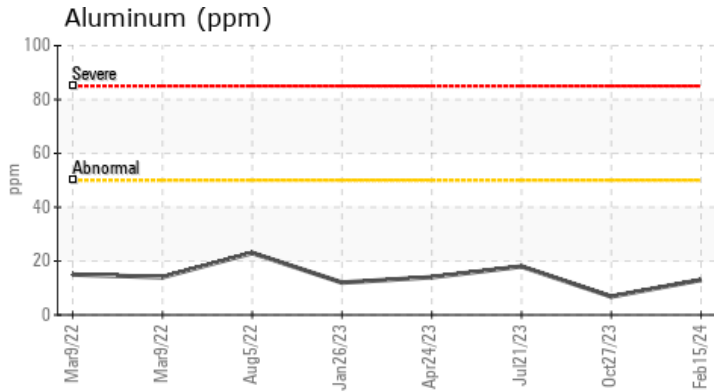
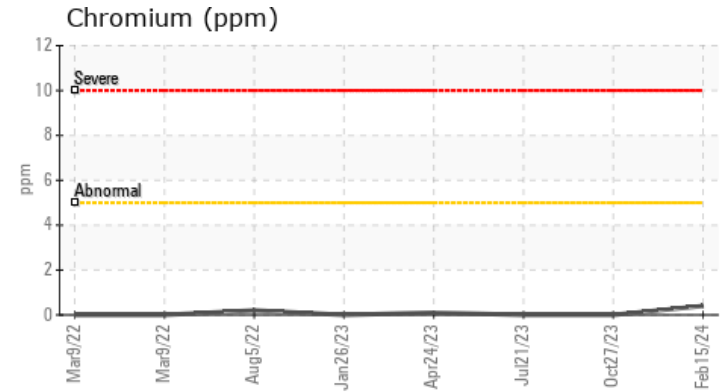
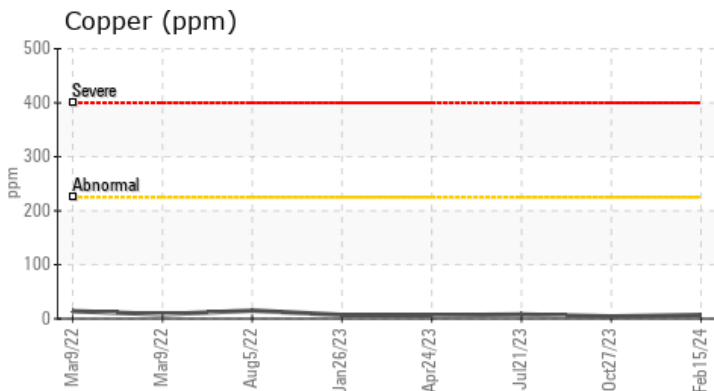
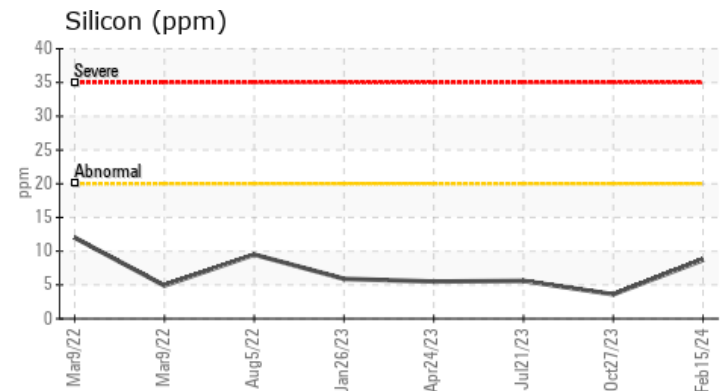
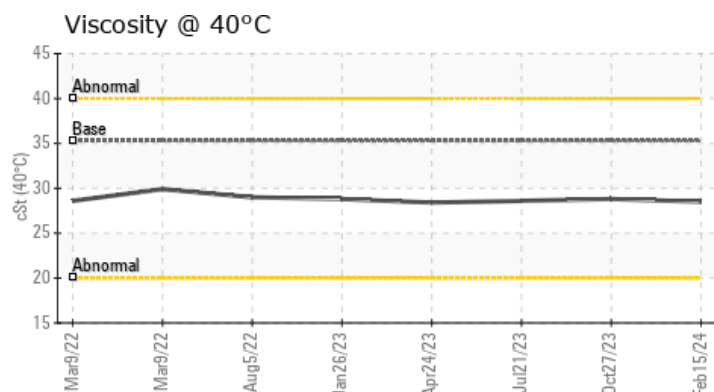
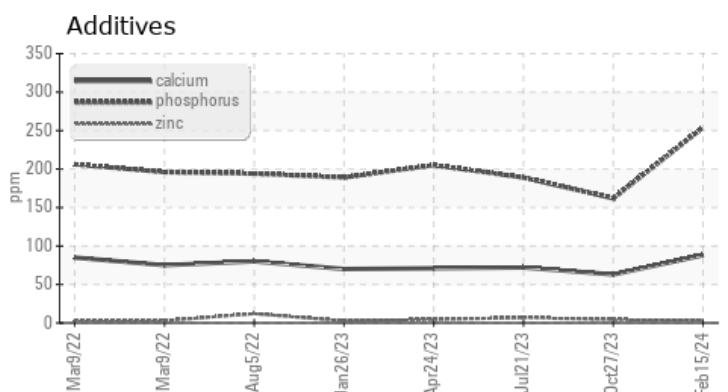
## VOLVO GRAPHS

**Diagnosis**  
 Resample at the next service interval to monitor. All component wear rates are normal. There is no indication of any contamination in the fluid. The condition of the fluid is acceptable for the time in service.
