CONSTRUCTION EQUIPMENT

RENTAL VOLVO A40G 752129 - TRANSMISSION

Sample No: VCP447448
Oil Type: VOLVO AUTOMATIC TRANSMISSION FLUID AT102
Job No: RENTAL

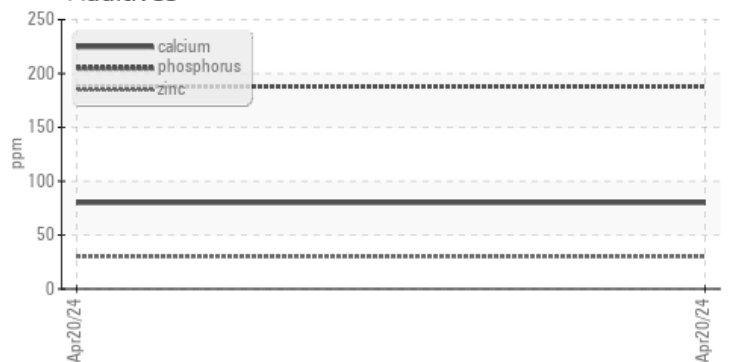
Additives

Calcium	ppm	█ 80	---	---	---
Magnesium	ppm	█ 2	---	---	---
Zinc	ppm	█ 30	---	---	---
Phosphorus	ppm	█ 188	---	---	---
Barium	ppm	█ 2	---	---	---
Boron	ppm	█ 87	---	---	---
