CONSTRUCTION EQUIPMENT A12671 VOLVO V8300-EVC A1110858 - REAR RIGHT FINAL DRIVE

Sample No: VCP454660 Oil Type: MOBIL MOBILUBE HD 80W90 Job No:

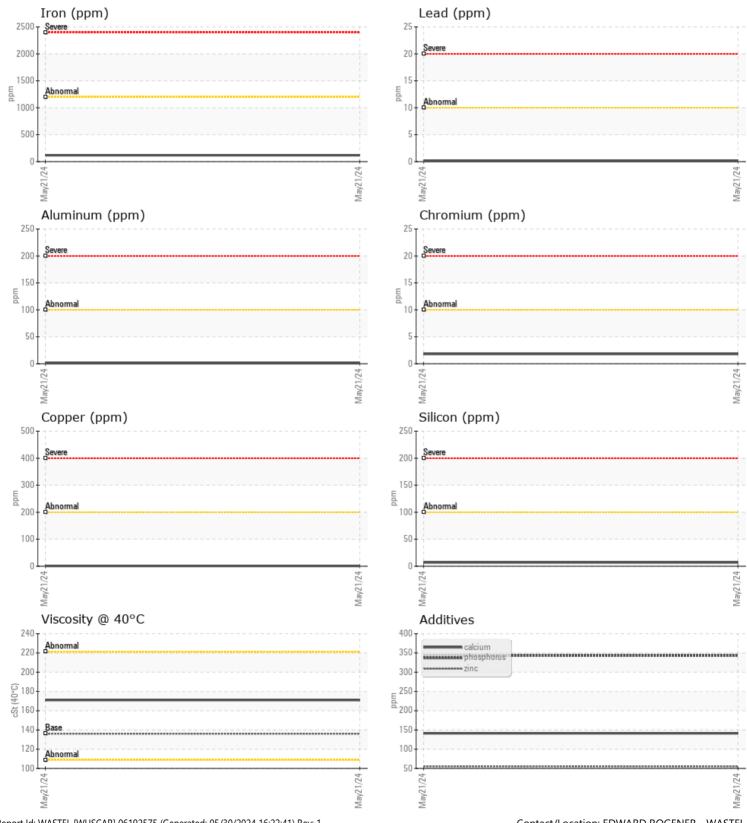
GRAPHS

INFORMATION				
Sample Number		VCP454660		 	
Sample Date		21 May 2024		 	WASTE MANAGEM
Machine Hours		575		 	400 PROGRESS DR
Oil Hours		575		 	TELFORD, PA
Oil Changed		Not Changd		 	US 18969-1191
Sample Status		NORMAL		 	Contact: EDWARD R
					erogener@wm.com
OIL CONI					T:
		<u>.</u>	<u>_</u>		F:
Visc @ 40°C	cSt	171		 	
VOLVO					Diagnosis
CONTAM	INATION				-
Water	%	NEG		 	Resample at the nex
Silicon				 	to monitor.All comp are normal. There is
Sodium	ppm	3		 	any contamination
Potassium	ppm	2		 	condition of the oil
POLASSIUM	ppm	Z		 	the time in service.
VOLVO					
VEAR M	IETALS				
Iron	ppm	117		 	
Copper	ppm	 <1		 	
Lead	ppm	 <1		 	
Tin	ppm	0		 	
Aluminum	ppm	<1		 	
Chromium	ppm	2		 	
Molybdenum	ppm	<1		 	
Nickel	ppm	<1		 	
Titanium	ppm	<1		 	
Silver	ppm	<1		 	
Manganese	ppm	2		 	
Vanadium	ppm	<1		 	
ADDITIV	ES				
Calcium	ppm	141		 	
Magnesium	ppm	5		 	
Zinc	ppm	55		 	
Phosphorus	ppm	343		 	
Barium	ppm	0		 	
banam	2211	— •

kt service interval onent wear rates no indication of in the oil. The is acceptable for
