# CONSTRUCTION EQUIPMENT

## VOLVO EC350E 310403 - DIESEL ENGINE

**Sample No:** ML0001591  
**Oil Type:** DIESEL ENGINE OIL SAE 15W40  
**Job No:**

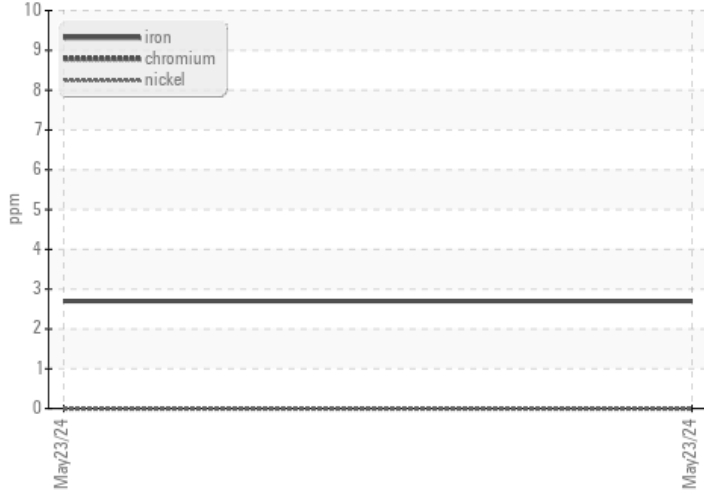
### Ferrous Alloys

Iron	ppm	█ 3	---	---	---
Copper	ppm	█ 6	---	---	---
Lead	ppm	█ <1	---	---	---
Tin	ppm	█ <1	---	---	---
Aluminum	ppm	█ 2	---	---	---
Chromium	ppm	█ 0	---	---	---
Molybdenum	ppm	█ 40	---	---	---
Nickel	ppm	█ 0	---	---	---
Titanium	ppm	█ 0	---	---	---
Silver	ppm	█ 0	---	---	---
Manganese	ppm	█ <1	---	---	---
Vanadium	ppm	0	---	---	---

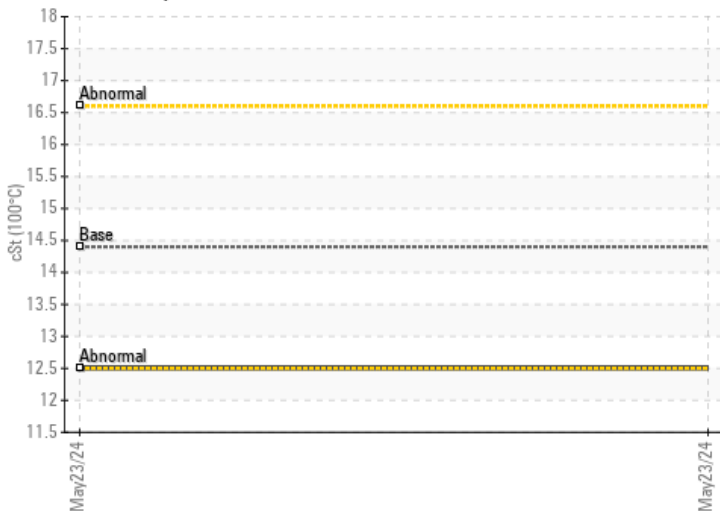
### Viscosity @ 100°C

Visc @ 100°C	cSt	█ 12.5	---	---	---
Base Number (BN)	mg KOH/g	█ 9.4	---	---	---
Oxidation (PA)	%	77	---	---	---

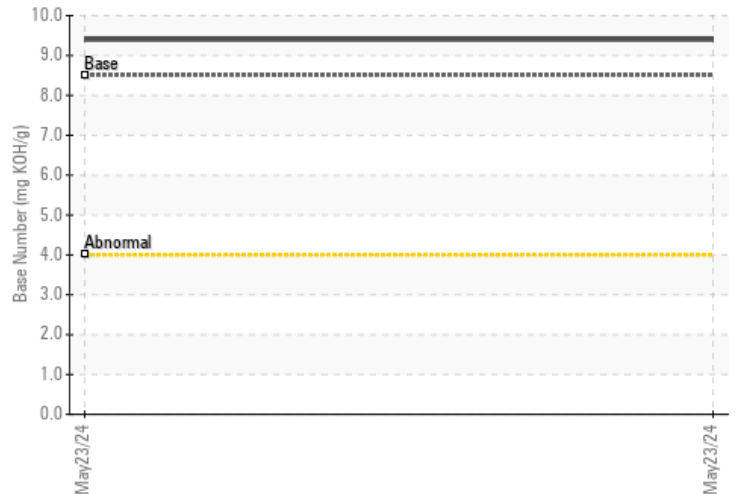
### Base Number

Resample at the next service interval to monitor. All component wear rates are normal. There is no indication of any contamination in the oil. The BN result indicates that there is suitable alkalinity remaining in the oil. The condition of the oil is acceptable for the time in service.
