CONSTRUCTION EQUIPMENT

HERC VOLVO L70H 623590 - HYDRAULIC SYSTEM

Sample No: VCP454977
Oil Type: VOLVO SUPER HYDRAULIC OIL 46
Job No: HERC

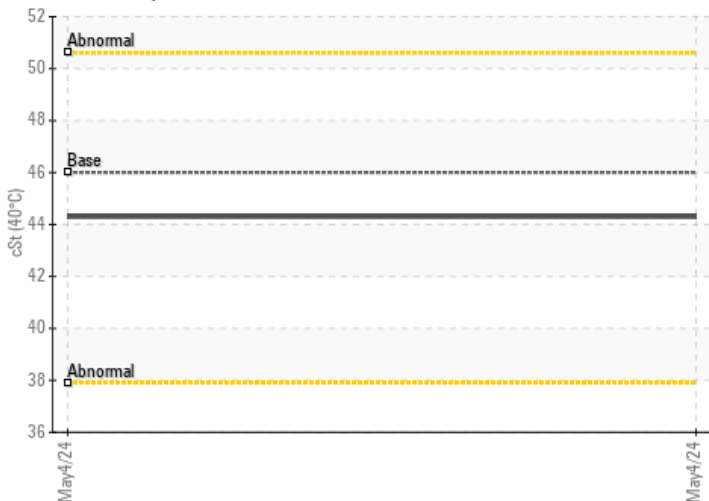
Viscosity @ 40°C

Visc @ 40°C	cSt	█ 44.3	---	---	---
Acid Number (AN)	mg KOH/g	█ 0.80	---	---	---
