CONSTRUCTION EQUIPMENT

UPAP-PHOENIX SW1034614 330144 VOLVO L90G 617701 - TRANSMISSION (AUTO)

Sample No: VCP454015
Oil Type: VOLVO AUTOMATIC TRANSMISSION FLUID AT102
Job No: SW1034614

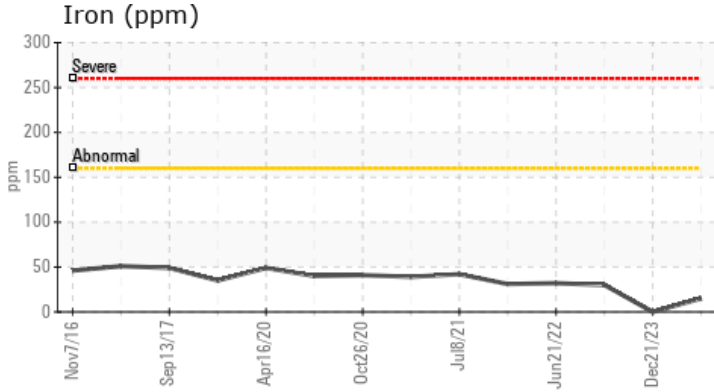
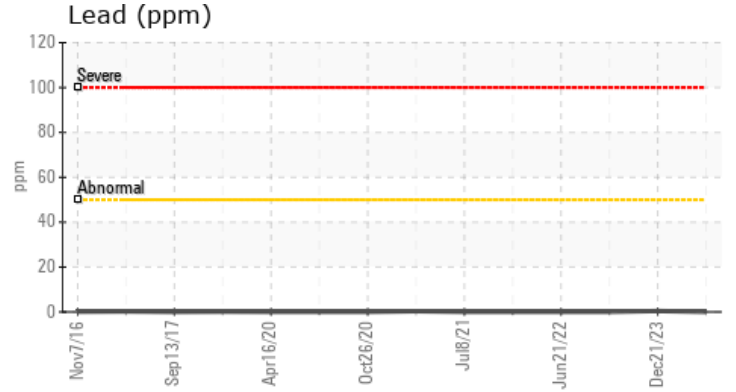
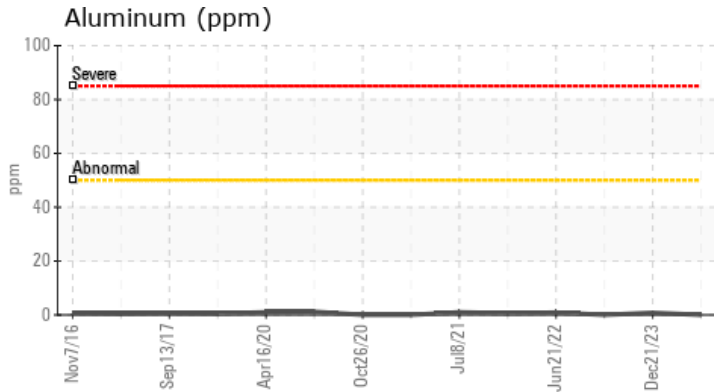
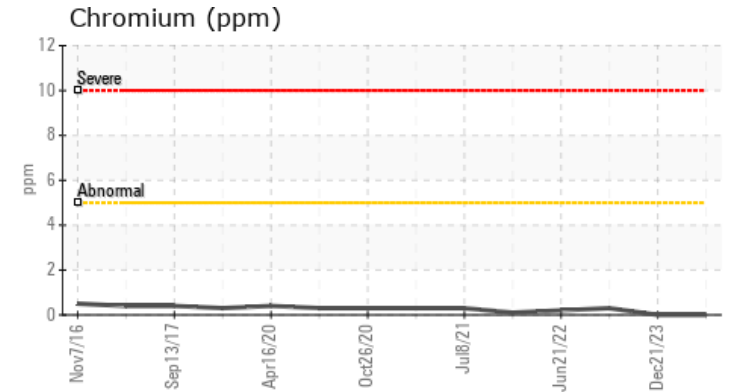
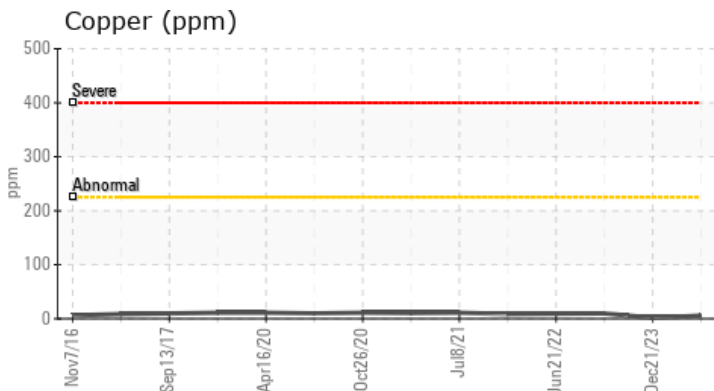
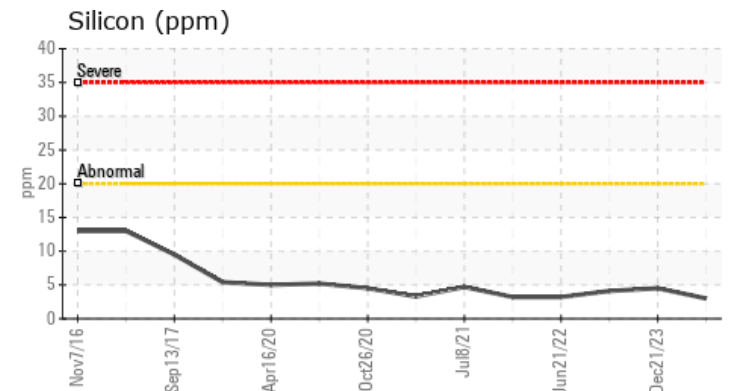
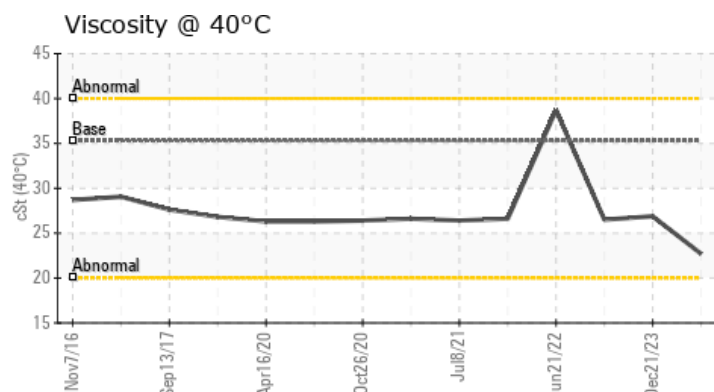
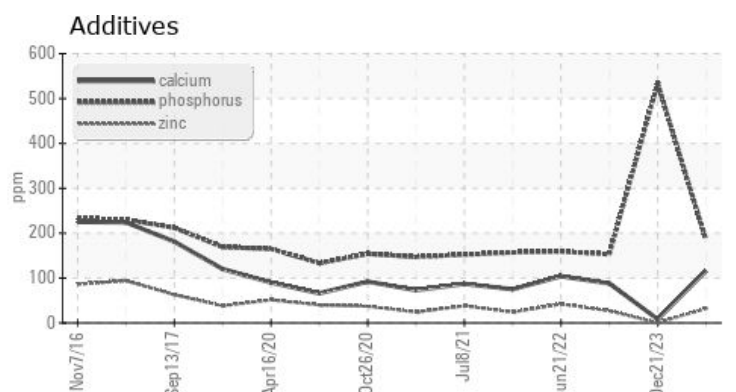
VOLVO GRAPHS

Resample at the next service interval to monitor. All component wear rates are normal. There is no indication of any contamination in the fluid. The condition of the fluid is acceptable for the time in service.
