# CONSTRUCTION EQUIPMENT

## KOMATSU WA500-8 WP7225 - TRANSMISSION (MANUAL)

**Sample No:** VCP443407  
**Oil Type:** KOMATSU 30W  
**Job No:**

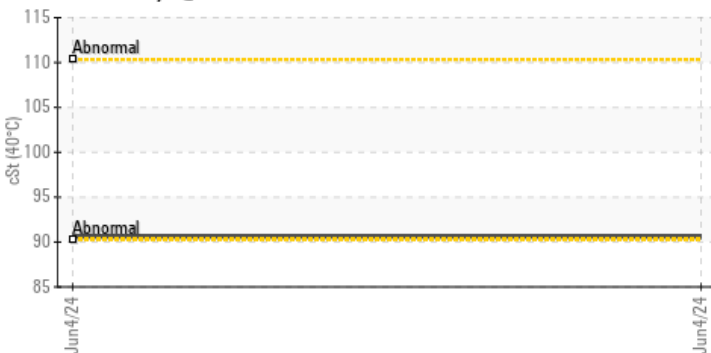
### Viscosity @ 40°C

Visc @ 40°C	cSt	█ 90.6	---	---	---
-------------	-----	--------	-----	-----	-----

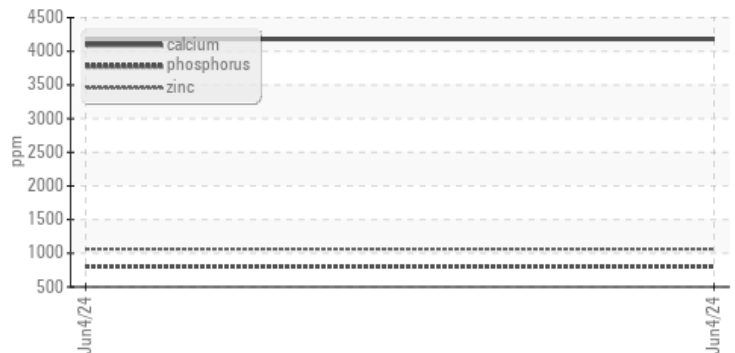
### Additives

Calcium	ppm	4183	---	---	---
Magnesium	ppm	12	---	---	---
Zinc	ppm	1062	---	---	---
Phosphorus	ppm	804	---	---	---
Barium	ppm	0	---	---	---
Boron	ppm	5	---	---	---
