CONSTRUCTION EQUIPMENT

729036 VOLVO A40G 342177 - DROP BOX

Sample No: VCP439771
Oil Type: VOLVO PREMIUM GEAR OIL 85W-140 GL-5
Job No: 729036

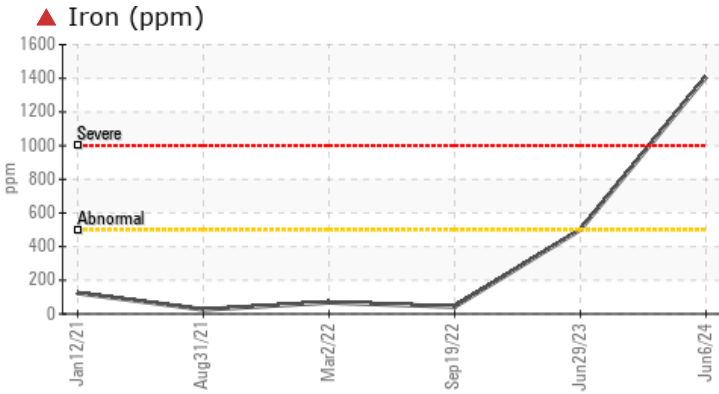
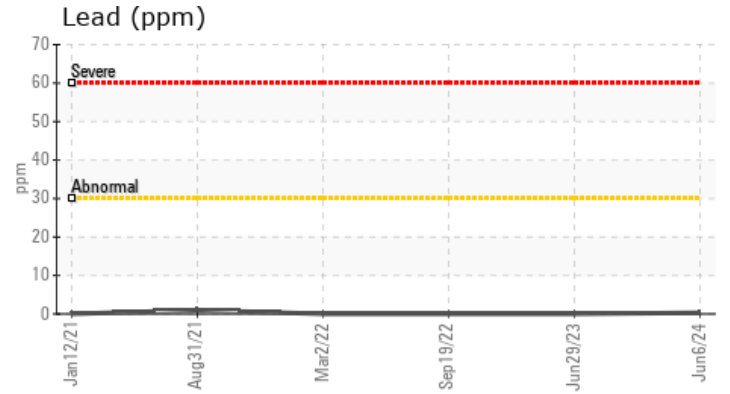
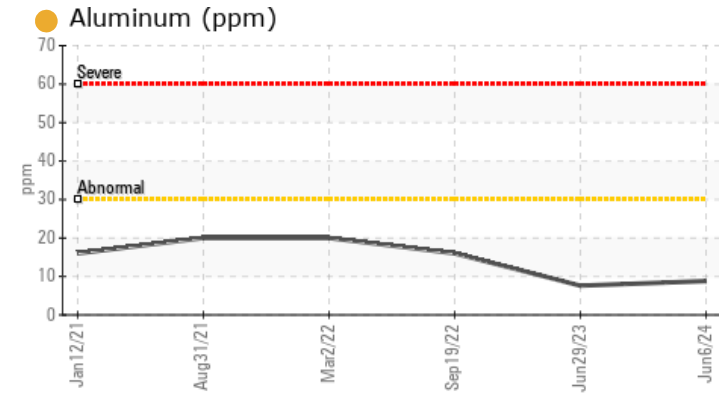
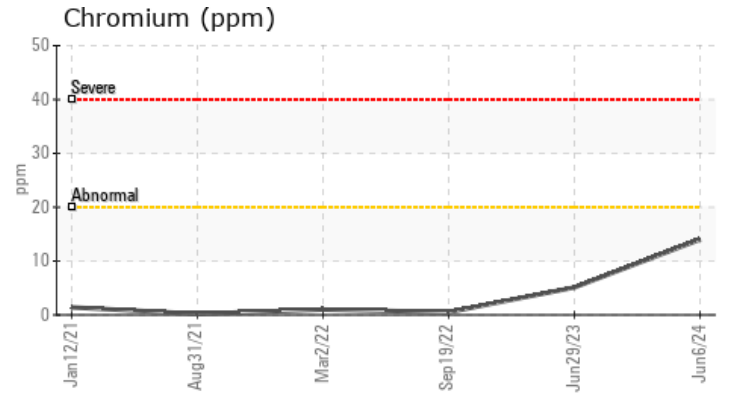
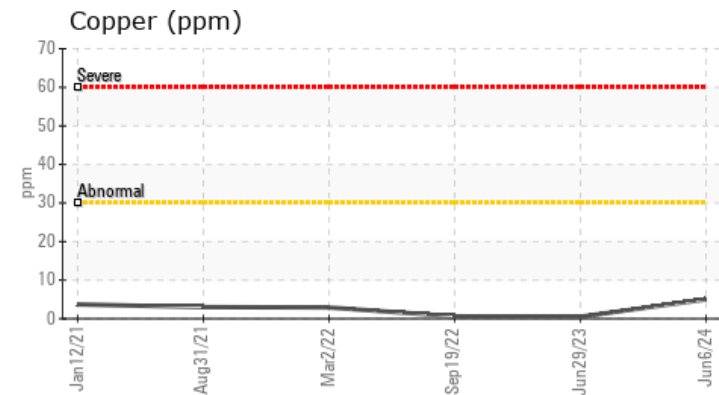
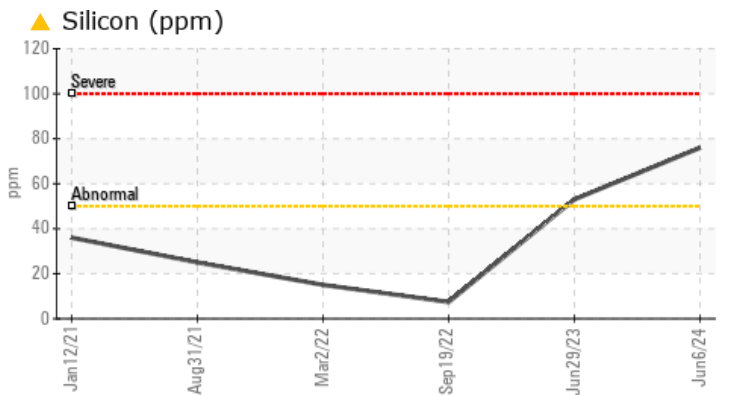
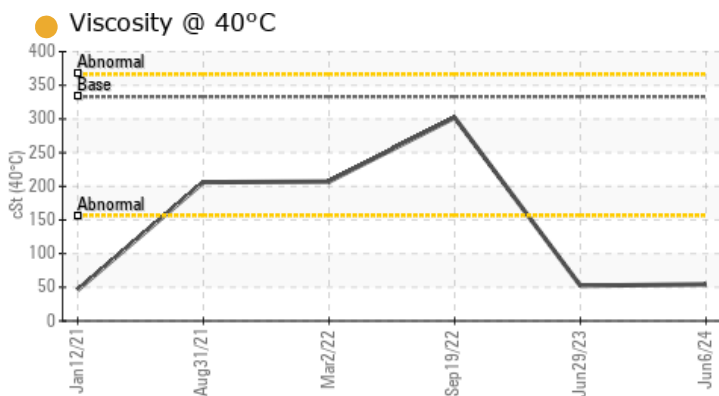
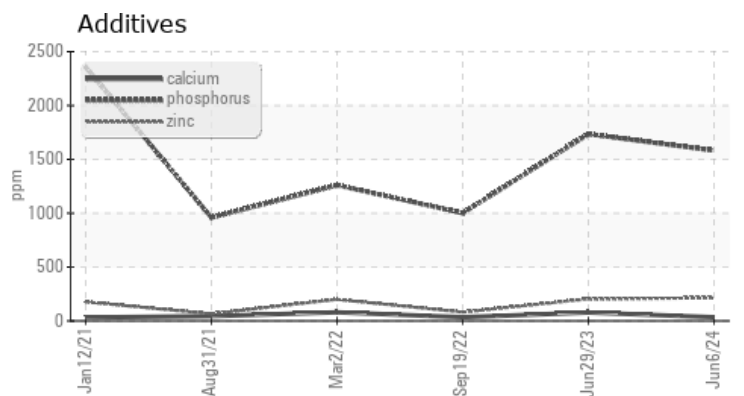
VOLVO GRAPHS

We advise that you check all areas where dirt can enter the system. We recommend that you drain the oil from the component if this has not already been done. We advise that you inspect for the source(s) of wear. We recommend an early resample to monitor this condition. Gear wear is indicated. Elemental levels of silicon (Si) and aluminum (Al) indicate alumina-silicate (coarse dirt) ingress. Moderate concentration of visible dirt/debris present in the oil. The oil viscosity is lower than normal. Confirm oil type. The oil is no longer serviceable as a result of the abnormal and/or severe wear.
