OIL ANALYSIS REPORT

Area
MANITOU FALLS GS
 Machine Id
FP2G1
 Component
Thrust Bearing
 Fluid
ESSO TERESSO ISO 46 (--- GAL)

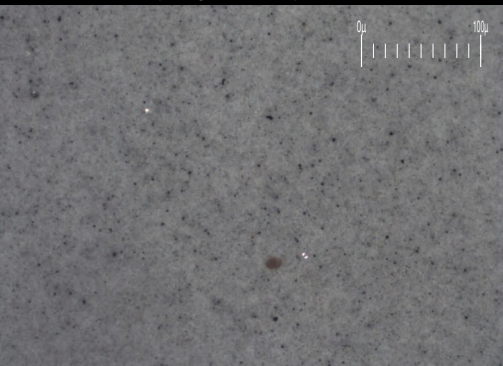
Particle Filter (Magn: 200 x)

The system cleanliness is acceptable for your target ISO 4406 cleanliness code. The system and fluid cleanliness is acceptable.

Resample at the next service interval to monitor.
 NOTE: Please provide information regarding reservoir capacity, filter type and micron rating with next sample.

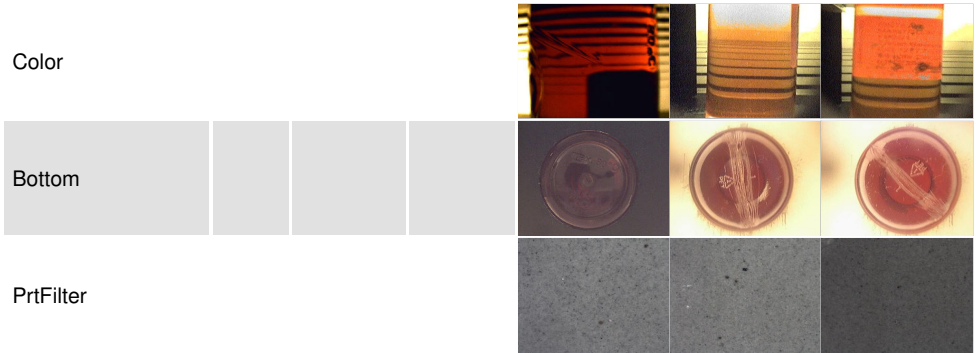
SAMPLE IMAGES	method	limit/base	current	history1	history2
---------------	--------	------------	---------	----------	----------

VISUAL	method	limit/base	current	history1	history2	
White Metal	scalar	Visual*	NONE	NONE	NONE	NONE
Yellow Metal	scalar	Visual*	NONE	NONE	NONE	NONE
Precipitate	scalar	Visual*	NONE	NONE	NONE	NONE
Silt	scalar	Visual*	NONE	NONE	NONE	NONE
Debris	scalar	Visual*	NONE	NONE	NONE	NONE
Sand/Dirt	scalar	Visual*	NONE	NONE	NONE	NONE
Appearance	scalar	Visual*	NORML	NORML	NORML	NORML
Odor	scalar	Visual*	NORML	NORML	NORML	NORML
Emulsified Water	scalar	Visual*	>2	NEG	NEG	NEG
Free Water	scalar	Visual*		NEG	NEG	NEG
