OIL ANALYSIS REPORT

Area
EAR FALLS GS
 Machine Id
FP1G1

Component
Thrust Bearing
 Fluid
ESSO TERESSO ISO 46 (--- GAL)

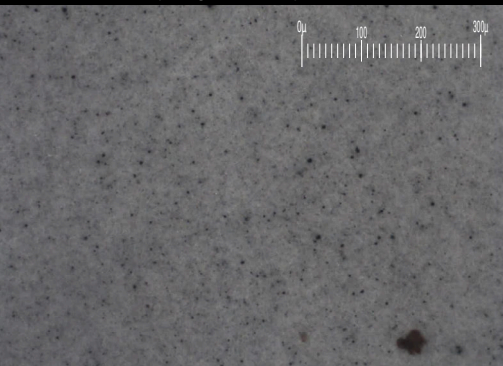
Particle Filter (Magn: 100 x)

The system cleanliness is acceptable for your target ISO 4406 cleanliness code. The system and fluid cleanliness is acceptable.

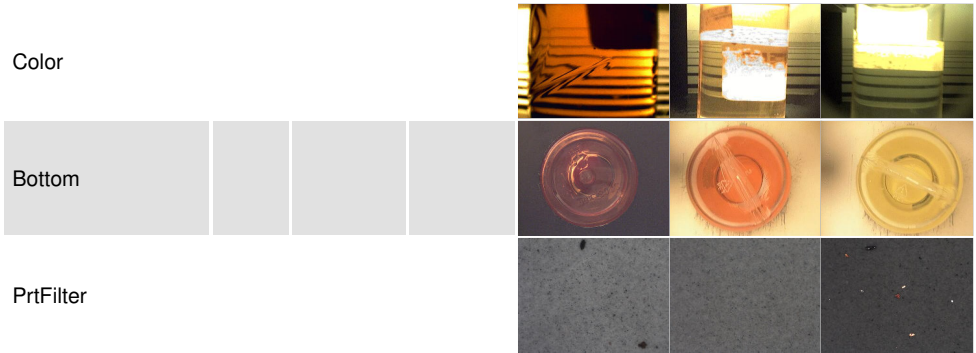
SAMPLE IMAGES	method	limit/base	current	history1	history2
---------------	--------	------------	---------	----------	----------

VISUAL	method	limit/base	current	history1	history2	
White Metal	scalar	Visual*	NONE	NONE	NONE	▲ VLITE
Yellow Metal	scalar	Visual*	NONE	NONE	NONE	▲ VLITE
Precipitate	scalar	Visual*	NONE	NONE	NONE	NONE
Silt	scalar	Visual*	NONE	NONE	NONE	NONE
Debris	scalar	Visual*	NONE	NONE	NONE	NONE
Sand/Dirt	scalar	Visual*	NONE	NONE	NONE	NONE
Appearance	scalar	Visual*	NORML	NORML	NORML	NORML
Odor	scalar	Visual*	NORML	NORML	NORML	NORML
Emulsified Water	scalar	Visual*	>2	NEG	NEG	NEG
Free Water	scalar	Visual*		NEG	NEG	NEG
