OIL ANALYSIS REPORT

Area
MANITOU FALLS GS
 Machine Id
FP2G5
 Component
Thrust Bearing
 Fluid
ESSO TERESSO ISO 46 (--- GAL)

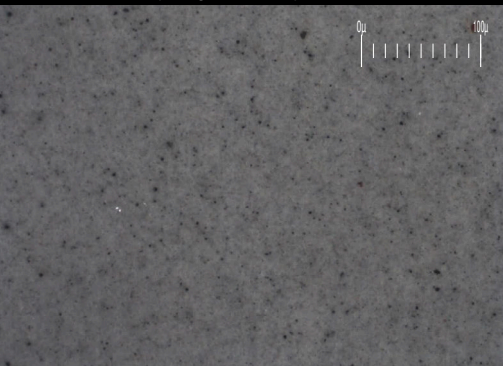
Particle Filter (Magn: 200 x)

The system cleanliness is acceptable for your target ISO 4406 cleanliness code. The system and fluid cleanliness is acceptable.

Resample at the next service interval to monitor.
 NOTE: Please provide information regarding reservoir capacity, filter type and micron rating with next sample.
