OIL ANALYSIS REPORT

Area
WHITEDOG FALLS GS
Machine Id
FP3G1
Component
Thrust Bearing
Fluid
ESSO TERESSO ISO 46 (--- GAL)

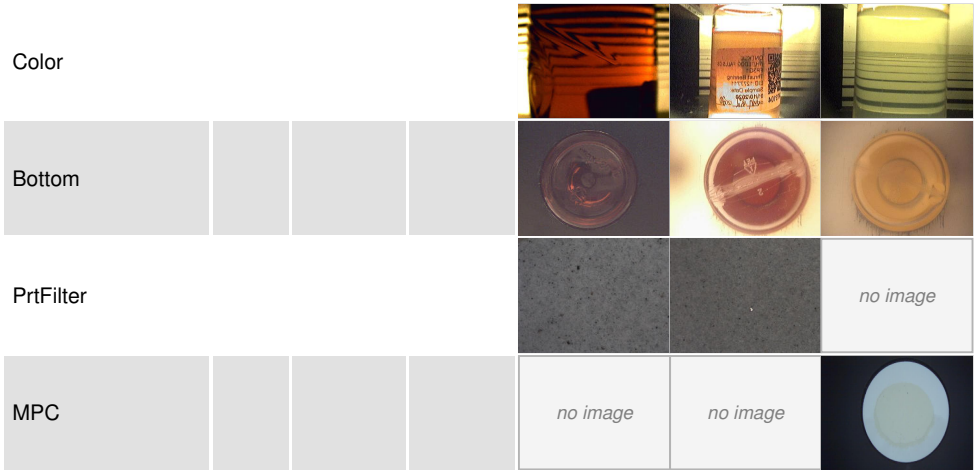
SAMPLE IMAGES		method	limit/base	current	history1	history2
---------------	--	--------	------------	---------	----------	----------

VISUAL		method	limit/base	current	history1	history2
White Metal	scalar	Visual*	NONE	NONE	NONE	NONE
Yellow Metal	scalar	Visual*	NONE	NONE	NONE	NONE
Precipitate	scalar	Visual*	NONE	NONE	NONE	NONE
Silt	scalar	Visual*	NONE	NONE	NONE	NONE
Debris	scalar	Visual*	NONE	NONE	NONE	NONE
Sand/Dirt	scalar	Visual*	NONE	NONE	NONE	NONE
Appearance	scalar	Visual*	NORML	NORML	NORML	NORML
Odor	scalar	Visual*	NORML	NORML	NORML	NORML
Emulsified Water	scalar	Visual*	>2	NEG	NEG	NEG
Free Water	scalar	Visual*		NEG	NEG	NEG
