# OIL ANALYSIS REPORT

Machine Id  
**MGT G1 PT**

Component  
**Lube System**

Fluid  
**ESSO TERESSO ISO 32 (1200 LTR)**

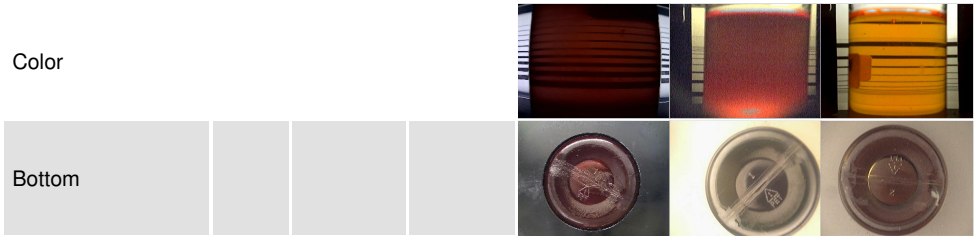
### SAMPLE IMAGES

VISUAL		method	limit/base	current	history1	history2
White Metal	scalar	Visual*	NONE	<b>NONE</b>	VLITE	NONE
Yellow Metal	scalar	Visual*	NONE	<b>NONE</b>	NONE	NONE
Precipitate	scalar	Visual*	NONE	<b>NONE</b>	NONE	NONE
Silt	scalar	Visual*	NONE	<b>NONE</b>	NONE	NONE
Debris	scalar	Visual*	NONE	<b>NONE</b>	VLITE	VLITE
Sand/Dirt	scalar	Visual*	NONE	<b>NONE</b>	NONE	NONE
Appearance	scalar	Visual*	NORML	<b>NORML</b>	NORML	NORML
Odor	scalar	Visual*	NORML	<b>NORML</b>	NORML	NORML
Emulsified Water	scalar	Visual*	>0.05	<b>NEG</b>	NEG	NEG
Free Water	scalar	Visual*		<b>NEG</b>	NEG	NEG

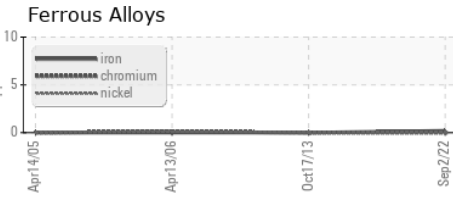
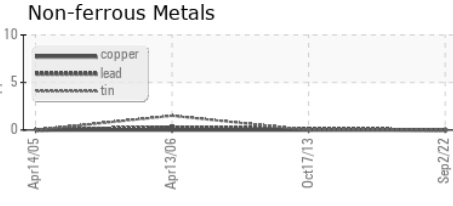
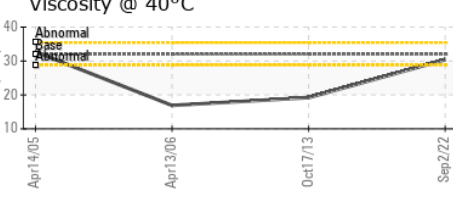
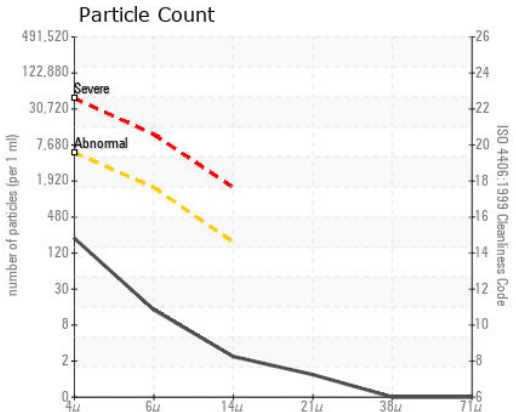
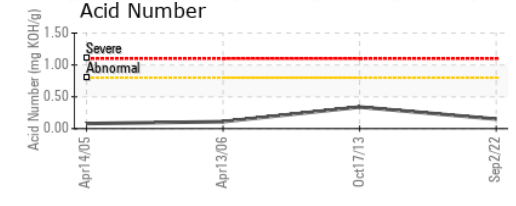
### GRAPHS

All component wear rates are normal.

The system cleanliness is acceptable for your target ISO 4406 cleanliness code. The system and fluid cleanliness is acceptable.

The AN level is acceptable for this fluid. The condition of the oil is suitable for further service.

Resample at the next service interval to monitor.
