# OIL ANALYSIS REPORT

## HYDROSTATIC TEST STAND

Hydraulic System

RADCOLUBE RHP5606 (--- GAL)

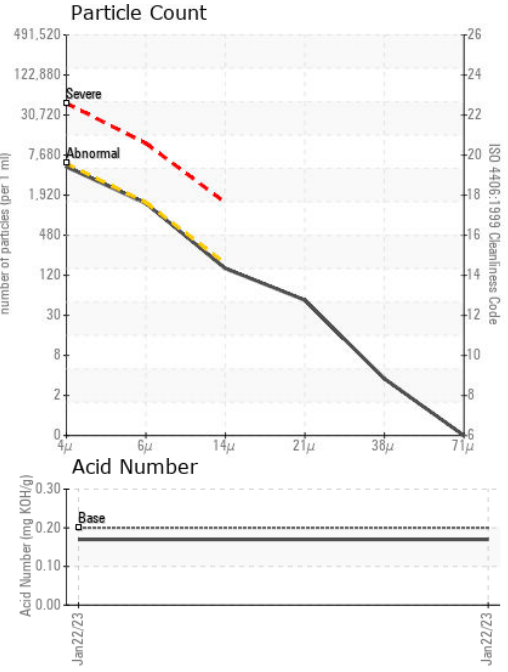
method	limit/base	current	history1	history2
Color				
Bottom

VISUAL	method	limit/base	current	history1	history2	
White Metal	scalar	Visual*	NONE	<b>NONE</b>	---	---
Yellow Metal	scalar	Visual*	NONE	<b>NONE</b>	---	---
Precipitate	scalar	Visual*	NONE	<b>NONE</b>	---	---
Silt	scalar	Visual*	NONE	<b>NONE</b>	---	---
Debris	scalar	Visual*	NONE	<b>NONE</b>	---	---
Sand/Dirt	scalar	Visual*	NONE	<b>NONE</b>	---	---
Appearance	scalar	Visual*	NORML	<b>NORML</b>	---	---
Odor	scalar	Visual*	NORML	<b>NORML</b>	---	---
Emulsified Water	scalar	Visual*	>0.05	<b>NEG</b>	---	---
Free Water	scalar	Visual*		<b>NEG</b>	---	---
