# OIL ANALYSIS REPORT

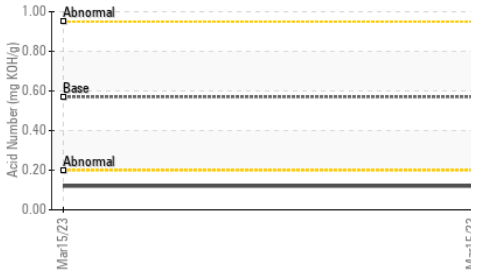
## Acid Number

method	limit/base	current	history1	history2		
Acid Number (AN)	mg KOH/g	ASTM D974*	0.57	<b>0.12</b>	---	---
VISUAL		method	limit/base	current	history1	history2
White Metal	scalar	Visual*	NONE	<b>NONE</b>	---	---
Yellow Metal	scalar	Visual*	NONE	<b>NONE</b>	---	---
Precipitate	scalar	Visual*	NONE	<b>NONE</b>	---	---
Silt	scalar	Visual*	NONE	<b>NONE</b>	---	---
Debris	scalar	Visual*	NONE	<b>NONE</b>	---	---
Sand/Dirt	scalar	Visual*	NONE	<b>NONE</b>	---	---
Appearance	scalar	Visual*	NORML	<b>NORML</b>	---	---
Odor	scalar	Visual*	NORML	<b>NORML</b>	---	---
Emulsified Water	scalar	Visual*	>0.05	<b>NEG</b>	---	---
Free Water	scalar	Visual*		<b>NEG</b>	---	---

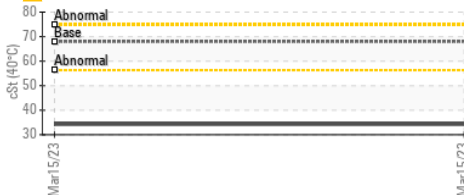
### Viscosity @ 40°C

method	limit/base	current	history1	history2		
Visc @ 40°C	cSt	ASTM D7279(m)	68	<b>▲ 34.3</b>	---	---
