Machine Id
LIEBHERR HS895 188297
 Component
Luffing Winch
 Fluid
PETRO CANADA TRAXON 75W90 SYNTHETIC (--- GAL)

OIL ANALYSIS REPORT

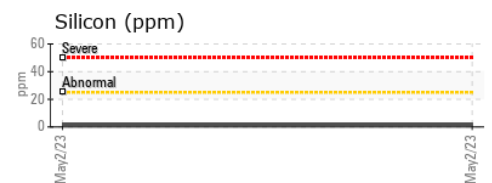
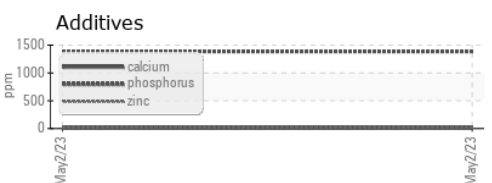
GRAPHS

All component wear rates are normal.

There is no indication of any contamination in the oil.

The condition of the oil is acceptable for the time in service.

Resample at the next service interval to monitor.
