OIL ANALYSIS REPORT

FERROGRAPHY REPORT

Area
Hull 2
 Machine Id
EH-G3 US TGB
 Component
Bearing
 Fluid
MOBIL DTE EXCEL ISO 68 (--- GAL)

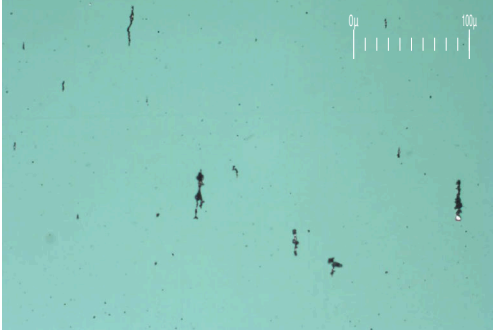
Magn: 200x Illum: BC

All component wear rates are normal. The direct-reading & analytical ferrographic results are normal indicating no abnormal wear in the system.
