OIL ANALYSIS REPORT

Area
Materials Handling/SW Pedestal Crane
 Machine Id
WPD471201 CRANE PEDESTAL SOUTH WEST

Component
1 Slewing Gearbox
 Fluid
MOBIL MOBILUBE HD 80W90 (--- GAL)

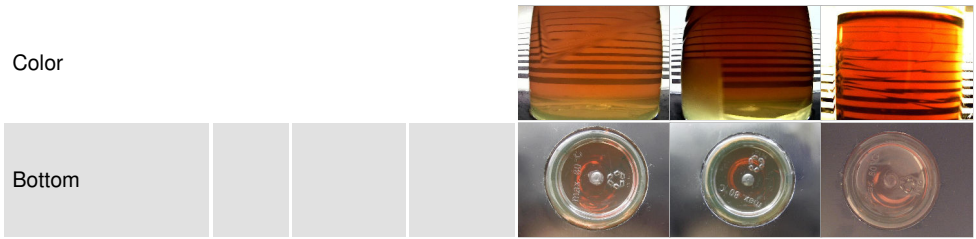
SAMPLE IMAGES	method	limit/base	current	history1	history2
---------------	--------	------------	---------	----------	----------

VISUAL	method	limit/base	current	history1	history2
White Metal	scalar	Visual*	NONE	NONE	NONE
Yellow Metal	scalar	Visual*	NONE	NONE	NONE
Precipitate	scalar	Visual*	NONE	NONE	NONE
Silt	scalar	Visual*	NONE	NONE	NONE
Debris	scalar	Visual*	NONE	NONE	NONE
Sand/Dirt	scalar	Visual*	NONE	NONE	NONE
Appearance	scalar	Visual*	NORML	NORML	NORML
Odor	scalar	Visual*	NORML	NORML	NORML
Emulsified Water	scalar	Visual*	>0.2	NEG	NEG
Free Water	scalar	Visual*		NEG	NEG

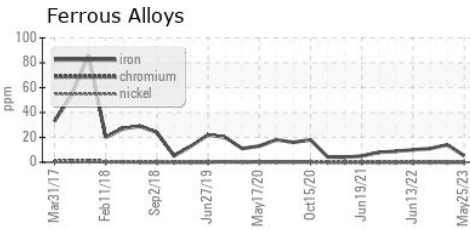
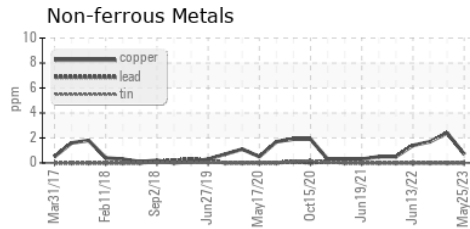
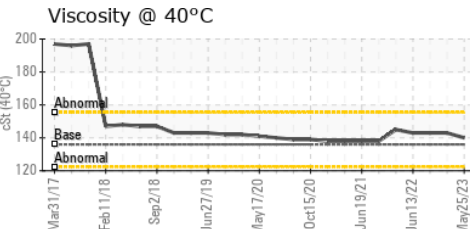
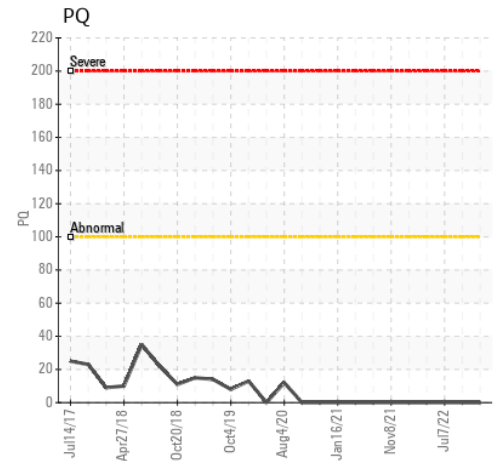
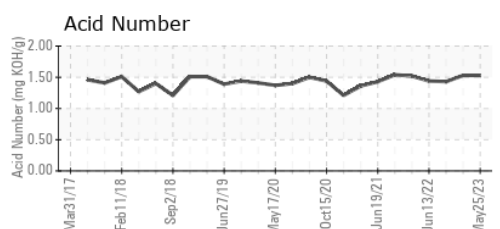
GRAPHS

All component wear rates are normal.

There is no indication of any contamination in the oil.

The AN level is acceptable for this fluid. The condition of the oil is suitable for further service.

Resample at the next service interval to monitor.
 NOTE: Please provide information regarding reservoir capacity, filter type and micron rating with next sample.
