# OIL ANALYSIS REPORT

# FERROGRAPHY REPORT

Area  
**(C-GOZA)**  
 Machine Id  
**[C-GOZA] L-392A 1252**  
 Component  
**Auxiliary Power Unit Jet Turbine**  
 Fluid  
**ROYCO 581 (--- GAL)**

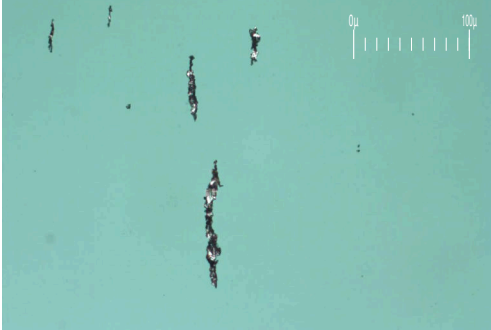
Magn: 200x Illum: BC

All component wear rates are normal. The direct-reading & analytical ferrographic results are normal indicating no abnormal wear in the system.
