# OIL ANALYSIS REPORT

Area  
**(C-FQWA)**  
 Machine Id  
**[C-FQWA] BEECHCRAFT 1900D PCE-PS0613**  
 Component  
**Right Jet Turbine**  
 Fluid  
**BP TURBO OIL 2380 (14 LTR)**

# FERROGRAPHY REPORT

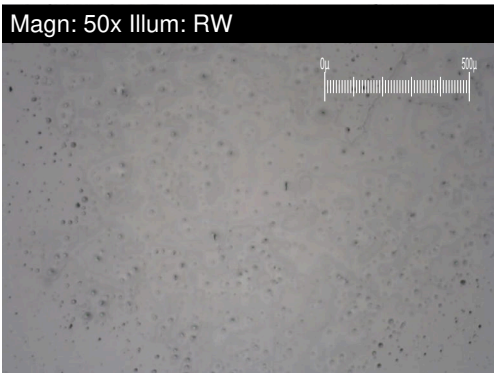
DR-FERROGRAPHY		method	limit/base	current	history1	history2
Large Particles		DR-Ferr*		<b>9.4</b>	---	---
Small Particles		DR-Ferr*		<b>5.9</b>	---	---
Total Particles		DR-Ferr*	>---	<b>15.3</b>	---	---
Large Particles Percentage	%	DR-Ferr*		<b>22.9</b>	---	---
Severity Index		DR-Ferr*		<b>33</b>	---	---

FERROGRAPHY		method	limit/base	current	history1	history2
Ferrous Rubbing	Scale 0-10	ASTM D7684*		<b>1</b>		
Ferrous Sliding	Scale 0-10	ASTM D7684*				
Ferrous Cutting	Scale 0-10	ASTM D7684*				
Ferrous Rolling	Scale 0-10	ASTM D7684*		<b>1</b>		
Ferrous Break-in	Scale 0-10	ASTM D7684*				
Ferrous Spheres	Scale 0-10	ASTM D7684*				
Ferrous Black Oxides	Scale 0-10	ASTM D7684*				
Ferrous Red Oxides	Scale 0-10	ASTM D7684*				
Ferrous Corrosive	Scale 0-10	ASTM D7684*				
Ferrous Other	Scale 0-10	ASTM D7684*				
Nonferrous Rubbing	Scale 0-10	ASTM D7684*				
Nonferrous Sliding	Scale 0-10	ASTM D7684*				
Nonferrous Cutting	Scale 0-10	ASTM D7684*				
Nonferrous Rolling	Scale 0-10	ASTM D7684*				
Nonferrous Other	Scale 0-10	ASTM D7684*				
Carbonaceous Material	Scale 0-10	ASTM D7684*				
Lubricant Degradation	Scale 0-10	ASTM D7684*				
Sand/Dirt	Scale 0-10	ASTM D7684*		<b>1</b>		
Fibres	Scale 0-10	ASTM D7684*				
Spheres	Scale 0-10	ASTM D7684*

All component wear rates are normal. The direct-reading & analytical ferrographic results are normal indicating no abnormal wear in the system.
