OIL ANALYSIS REPORT

Machine Id
R-2 AGITATOR

Component
Gearbox

Fluid
MOBIL SHC 630 (--- GAL)

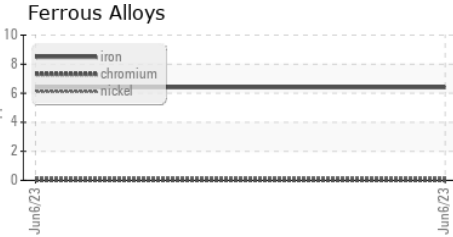
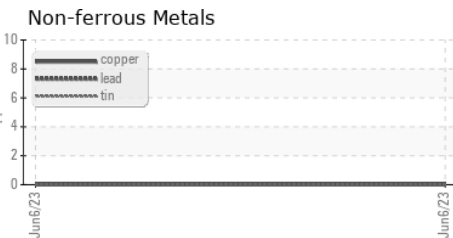
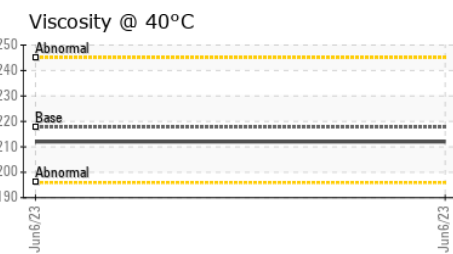
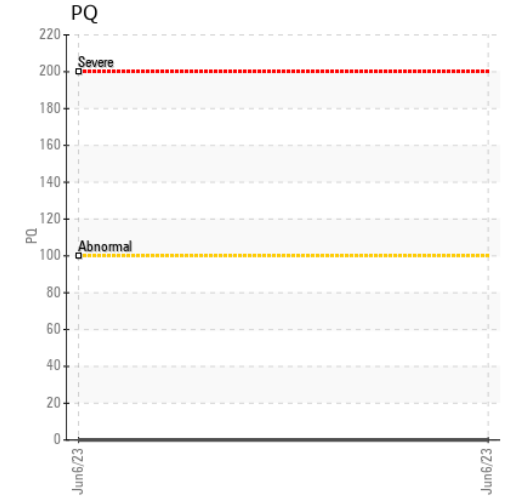
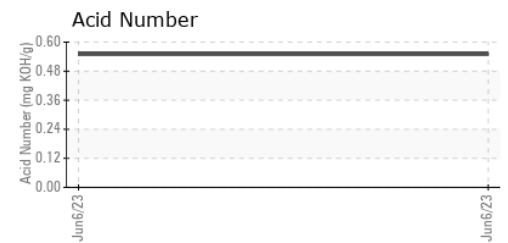
GRAPHS

All component wear rates are normal.

There is no indication of any contamination in the oil.

The AN level is acceptable for this fluid. The condition of the oil is suitable for further service.

Resample at the next service interval to monitor.
NOTE: Please provide information regarding reservoir capacity, filter type and micron rating with next sample.
