PROBLEM SUMMARY

Area
Societe via Quebec City - 888017
 Machine Id
XB094
 Component
Hydraulic System
 Fluid
NOT GIVEN (--- GAL)

OIL ANALYSIS REPORT

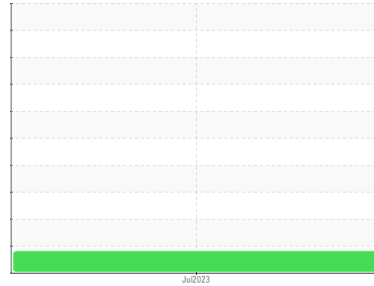
Sample Rating Trend

Sample Status			ATTENTION	---	---
Particles >4µm	ASTM D7647	>5000	▲ 5417	---	---
Oil Cleanliness	ISO 4406 (c)	>19/17/14	▲ 20/15/10	---	---

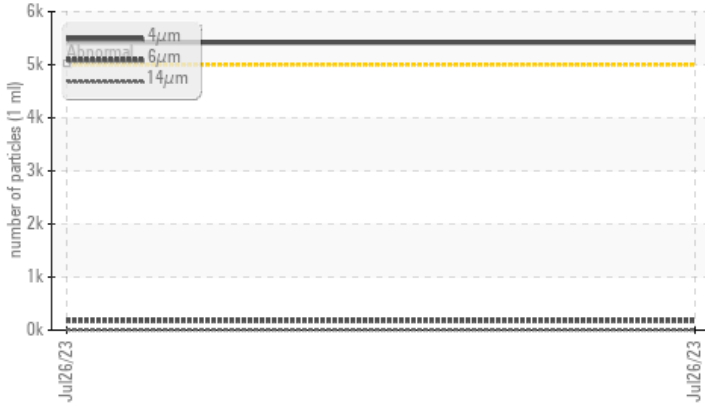
▲ Particle Trend

- ▲ **Recommendation**
This is a baseline read-out on the submitted sample.
- Wear**
{not applicable}
- ▲ **Contamination**
Particles >4µm and oil cleanliness are notably high.
- Fluid Condition**
{not applicable}

This is a baseline read-out on the submitted sample.

There are no recommended actions for this sample.

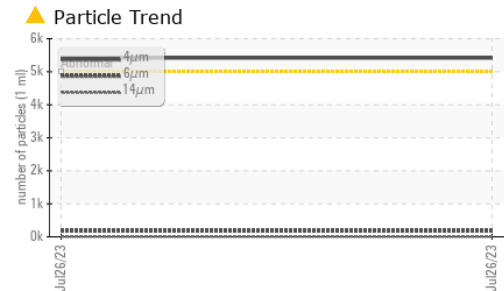
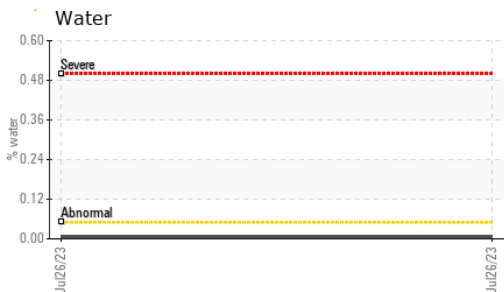
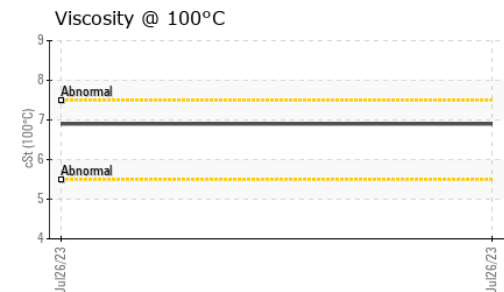
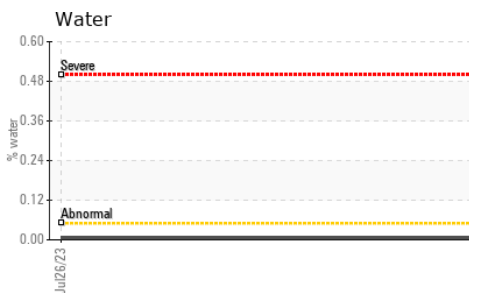
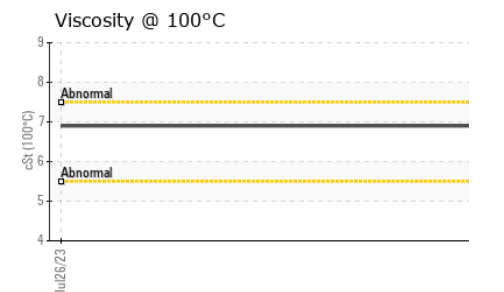
method	limit/base	current	history1	history2
Particles >4µm	ASTM D7647	>5000	▲ 5417	---	---
Particles >6µm	ASTM D7647	>1300	179	---	---
Particles >14µm	ASTM D7647	>160	7	---	---
Particles >21µm	ASTM D7647	>40	2	---	---
Particles >38µm	ASTM D7647	>10	0	---	---
Particles >71µm	ASTM D7647	>3	0	---	---
Oil Cleanliness	ISO 4406 (c)	>19/17/14	▲ 20/15/10	---	---
