OIL ANALYSIS REPORT

Area
Cascades - C13100
 Machine Id
AG186-R
 Component
Hydraulic System
 Fluid
AW HYDRAULIC OIL ISO 46 (--- GAL)

Laboratory : WearCheck - C8-1175 Appleby Line, Burlington, ON L7L 5H9
Sample No. : E30000088 **Received** : 18 Aug 2023
Lab Number : **02576771** **Diagnosed** : 25 Aug 2023
Unique Number : 5629831 **Diagnostician** : Tatiana Sorkina
Test Package : IND 2 (Additional Tests: KF, KV100, VI)

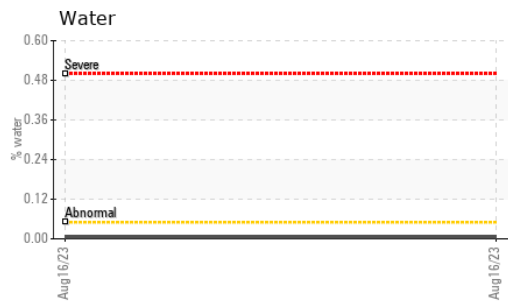
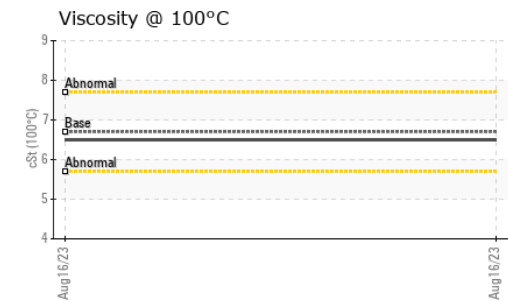
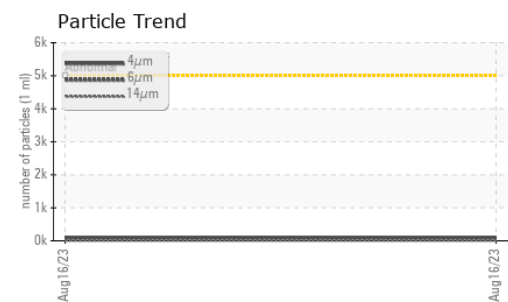
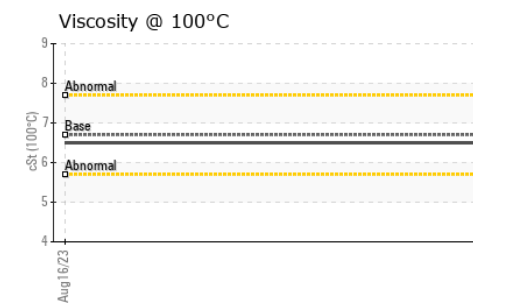
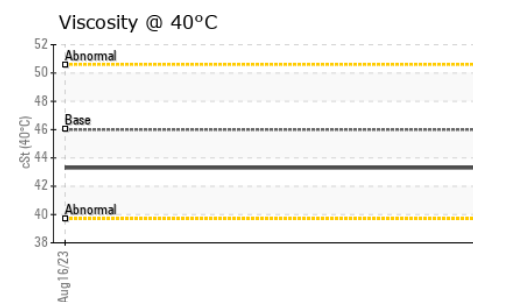
FLUID DEGRADATION		method	limit/base	current	history1	history2
Acid Number (AN)	mg KOH/g	ASTM D974*	0.57	0.35	---	---
VISUAL		method	limit/base	current	history1	history2
White Metal	scalar	Visual*	NONE	NONE	---	---
Yellow Metal	scalar	Visual*	NONE	NONE	---	---
Precipitate	scalar	Visual*	NONE	NONE	---	---
Silt	scalar	Visual*	NONE	NONE	---	---
Debris	scalar	Visual*	NONE	NONE	---	---
Sand/Dirt	scalar	Visual*	NONE	NONE	---	---
Appearance	scalar	Visual*	NORML	NORML	---	---
Odor	scalar	Visual*	NORML	NORML	---	---
Emulsified Water	scalar	Visual*	>0.05	NEG	---	---
Free Water	scalar	Visual*		NEG	---	---

FLUID PROPERTIES		method	limit/base	current	history1	history2
Visc @ 40°C	cSt	ASTM D7279(m)	46	43.3	---	---
Visc @ 100°C	cSt	ASTM D7279(m)	6.7	6.5	---	---
Viscosity Index (VI)	Scale	ASTM D2270*	97	99	---	---
