Machine Id  
**SAW TABLE**

Component  
**Hydraulic System**

Fluid  
**AW HYDRAULIC OIL ISO 32 (--- GAL)**

# OIL ANALYSIS REPORT

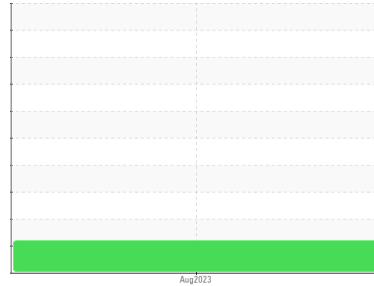
Sample Rating Trend

### ▲ Particle Trend

Sample Status			<b>ABNORMAL</b>	---	---
Particles >4µm	ASTM D7647	>5000	<b>▲ 10835</b>	---	---
Particles >6µm	ASTM D7647	>1300	<b>▲ 2229</b>	---	---
Oil Cleanliness	ISO 4406 (c)	>19/17/14	<b>▲ 21/18/13</b>	---	---

Little or no information is provided as to the component and lubricant being tested. Recommendations are therefore generic in nature and may not apply to the current application. Please forward information as to equipment type, reservoir capacity, lubricant type and any pertinent information to allow for a more accurate assessment. We recommend you service the filters on this component. We recommend an early resample to monitor this condition. The fluid was not specified, however, a fluid match indicates that this fluid is (GENERIC) AW HYDRAULIC OIL ISO 32. Please confirm.

Action	Status	Date	Done By	Description
Change Filter	---	---	?	We recommend you service the filters on this component.
Resample	---	---	?	We recommend an early resample to monitor this condition.
Alert	---	---	?	Little or no information is provided as to the component and lubricant being tested. Recommendations are therefore generic in nature and may not apply to the current application. Please forward information as to equipment type, reservoir capacity, lubricant type and any pertinent information to allow for a more accurate assessment.
Information Required	---	---	?	NOTE: Please provide information regarding reservoir capacity, filter type and micron rating with next sample.

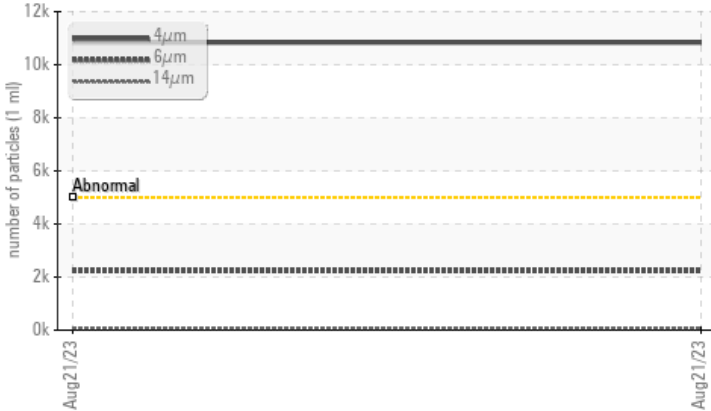
There is a moderate amount of silt (particulates < 14 microns in size) present in the oil.

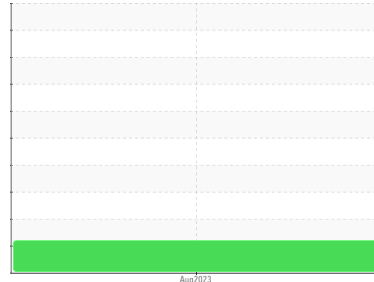
Sample Rating Trend

All component wear rates are normal.

Little or no information is provided as to the component and lubricant being tested. Recommendations are therefore generic in nature and may not apply to the current application. Please forward information as to equipment type, reservoir capacity, lubricant type and any pertinent information to allow for a more accurate assessment. We recommend you service the filters on this component. We recommend an early resample to monitor this condition. The fluid was not specified, however, a fluid match indicates that this fluid is (GENERIC) AW HYDRAULIC OIL ISO 32. Please confirm.
