OIL ANALYSIS REPORT

Machine Id **OKUMA 2 HEADSTOCK SPINDLE LUBE**

Component
Gearbox
Fluid
MOBIL VELOCITE OIL NO.10 (30 LTR)

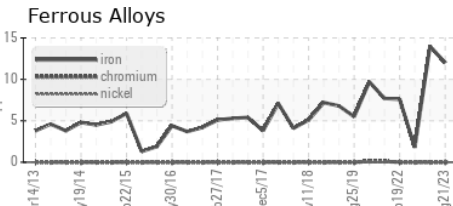
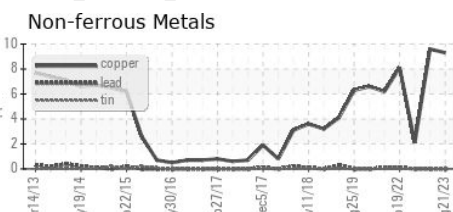
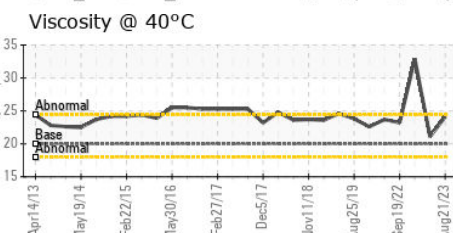
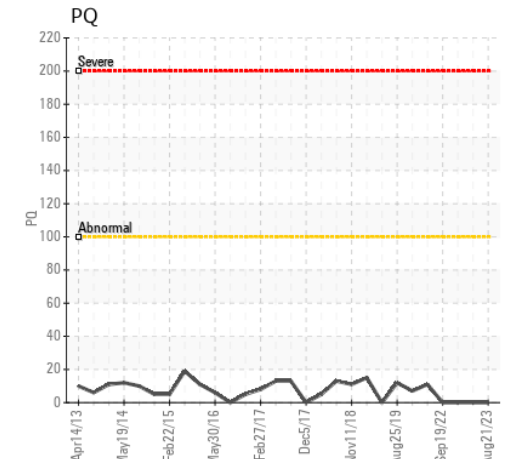
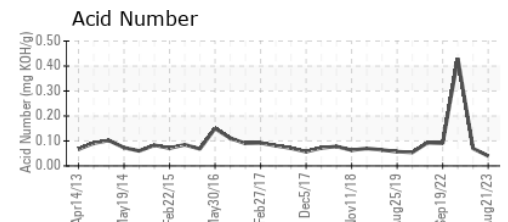
GRAPHS

All component wear rates are normal.

There is no indication of any contamination in the oil.

The AN level is acceptable for this fluid. The condition of the oil is suitable for further service.

Resample at the next service interval to monitor.
