OIL ANALYSIS REPORT

Area
SAB1
 Machine Id
SAB1 G9
 Component
Turbine Bearing
 Fluid
ESSO TERESSO ISO 46 (150 LTR)

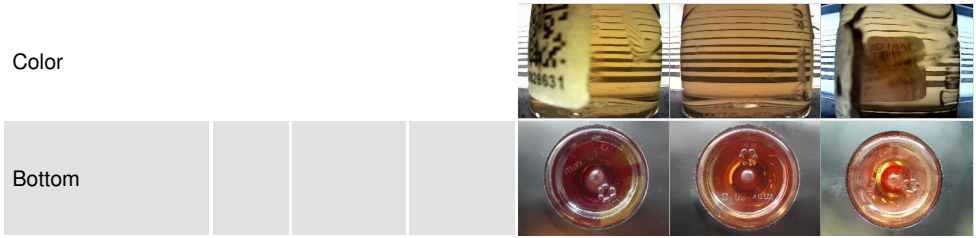
SAMPLE IMAGES

VISUAL		method	limit/base	current	history1	history2
White Metal	scalar	Visual*	NONE	NONE	NONE	NONE
Yellow Metal	scalar	Visual*	NONE	NONE	NONE	NONE
Precipitate	scalar	Visual*	NONE	NONE	NONE	NONE
Silt	scalar	Visual*	NONE	NONE	NONE	NONE
Debris	scalar	Visual*	NONE	NONE	NONE	NONE
Sand/Dirt	scalar	Visual*	NONE	NONE	NONE	NONE
Appearance	scalar	Visual*	NORML	NORML	NORML	NORML
Odor	scalar	Visual*	NORML	NORML	NORML	NORML
Emulsified Water	scalar	Visual*	>2	NEG	NEG	NEG
Free Water	scalar	Visual*		NEG	NEG	NEG

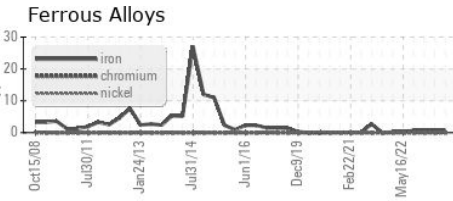
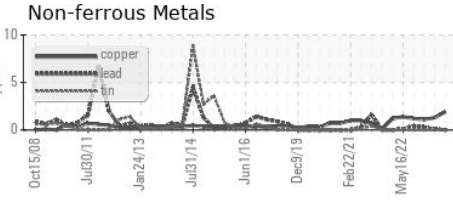
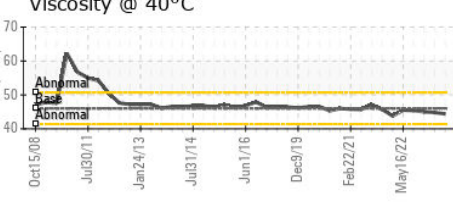
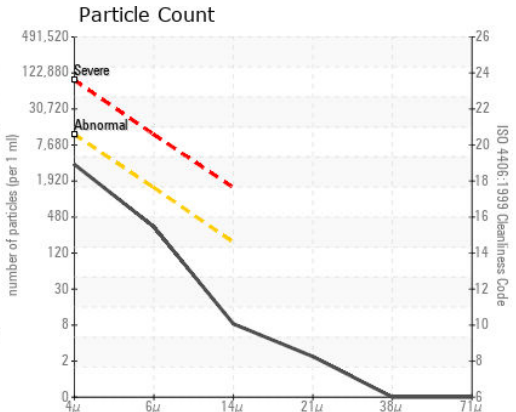
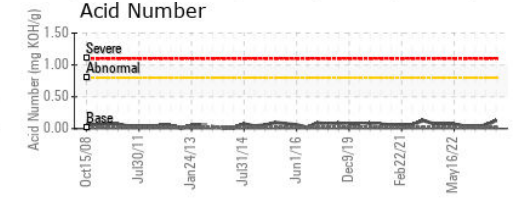
GRAPHS

All component wear rates are normal.

The system cleanliness is acceptable for your target ISO 4406 cleanliness code. The system and fluid cleanliness is acceptable.

The AN level is acceptable for this fluid. The condition of the oil is suitable for further service.

Resample at the next service interval to monitor.
