OIL ANALYSIS REPORT

Area
SAB1
 Machine Id
SAB1 G2 Governor
 Component
Hydraulic System
 Fluid
ESSO TERESSO ISO 46 (1600 LTR)

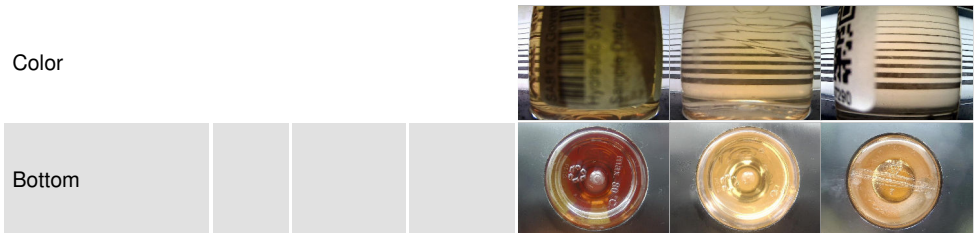
SAMPLE IMAGES	method	limit/base	current	history1	history2
---------------	--------	------------	---------	----------	----------

VISUAL	method	limit/base	current	history1	history2
White Metal	scalar	Visual*	NONE	NONE	NONE
Yellow Metal	scalar	Visual*	NONE	NONE	NONE
Precipitate	scalar	Visual*	NONE	NONE	NONE
Silt	scalar	Visual*	NONE	NONE	NONE
Debris	scalar	Visual*	NONE	NONE	NONE
Sand/Dirt	scalar	Visual*	NONE	NONE	NONE
Appearance	scalar	Visual*	NORML	NORML	NORML
Odor	scalar	Visual*	NORML	NORML	NORML
Emulsified Water	scalar	Visual*	>0.05	NEG	NEG
Free Water	scalar	Visual*		NEG	NEG

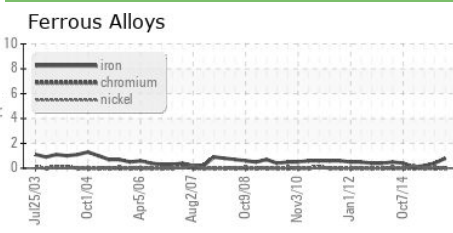
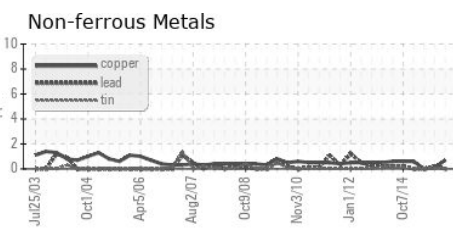
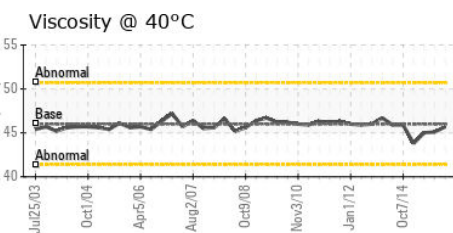
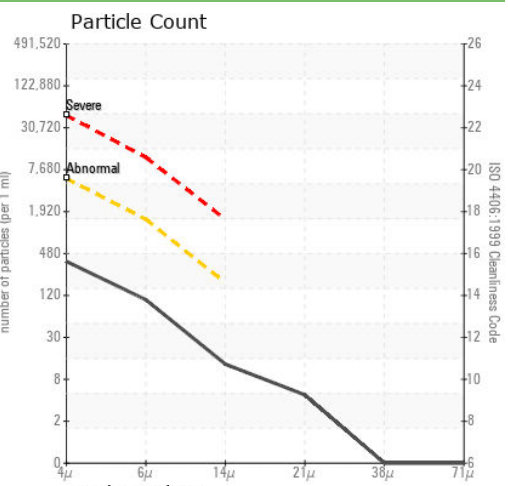
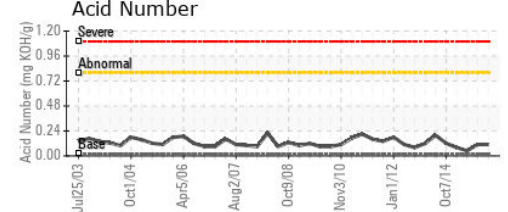
GRAPHS

method	limit/base	current	history1	history2	
Particles >4µm	ASTM D7647	>5000	325	▲ 23973	2621
Particles >6µm	ASTM D7647	>1300	92	▲ 4484	468
Particles >14µm	ASTM D7647	>160	11	60	14
Particles >21µm	ASTM D7647	>40	4	9	4
Particles >38µm	ASTM D7647	>10	0	0	0
Particles >71µm	ASTM D7647	>3	0	0	0
Oil Cleanliness	ISO 4406 (c)	>19/17/14	16/14/11	▲ 22/19/13	19/16/11
