# OIL ANALYSIS REPORT

Area  
**(C-GSNM) SKYNORTH AIR LTD**  
 Machine Id  
**BEECHCRAFT PCE51100**  
 Component  
**Left Jet Turbine**  
 Fluid  
**EASTMAN TURBO OIL 2380 (--- GAL)**

# FERROGRAPHY REPORT

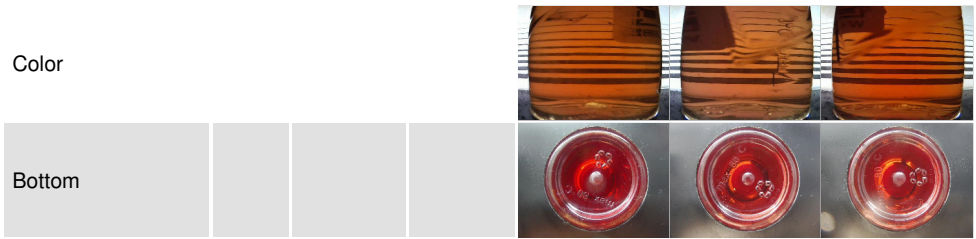
SAMPLE IMAGES	method	limit/base	current	history1	history2
---------------	--------	------------	---------	----------	----------

VISUAL	method	limit/base	current	history1	history2
White Metal	scalar	Visual*	NONE	NONE	NONE
Yellow Metal	scalar	Visual*	NONE	NONE	NONE
Precipitate	scalar	Visual*	NONE	NONE	NONE
Silt	scalar	Visual*	NONE	NONE	NONE
Debris	scalar	Visual*	NONE	NONE	NONE
Sand/Dirt	scalar	Visual*	NONE	NONE	NONE
Appearance	scalar	Visual*	NORML	NORML	NORML
Odor	scalar	Visual*	NORML	NORML	NORML
Emulsified Water	scalar	Visual*	>0.1	NEG	NEG
Free Water	scalar	Visual*		NEG	NEG

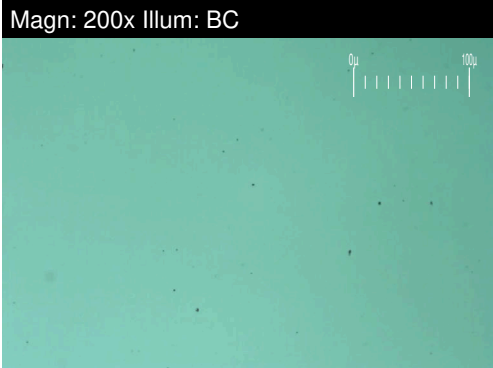
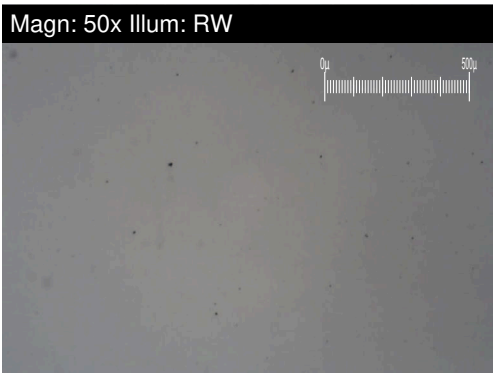
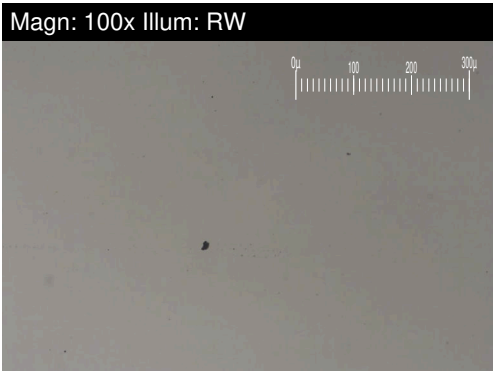
All component wear rates are normal. The direct-reading & analytical ferrographic results are normal indicating no abnormal wear in the system.
