OIL ANALYSIS REPORT

Machine Id
#2 BLAC (S/N 10585803)

Component
Unknown Component

Fluid
SHELL TURBO T ISO 46 (--- GAL)

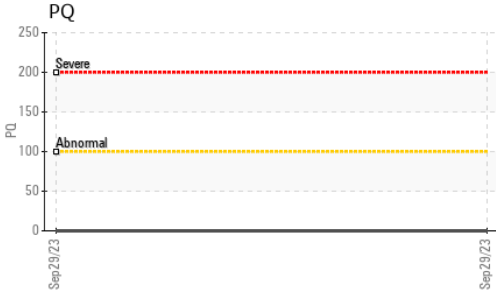
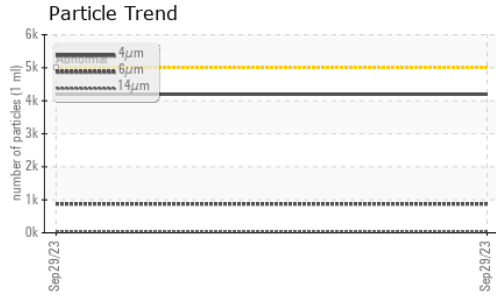
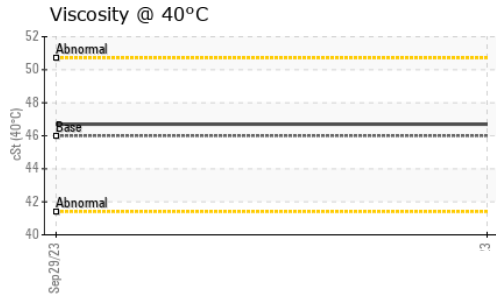
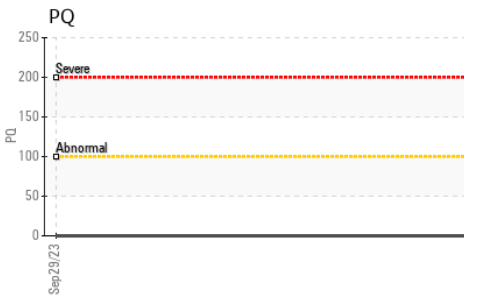
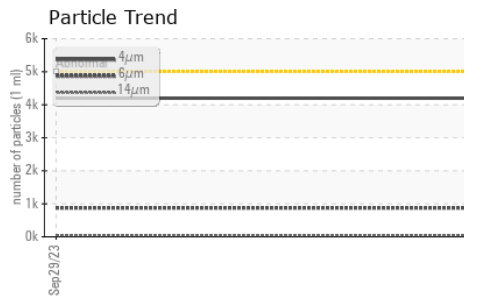
All component wear rates are normal.

The system cleanliness is acceptable for your target ISO 4406 cleanliness code. The system and fluid cleanliness is acceptable.

The AN level is acceptable for this fluid. The condition of the sample is suitable for further service.

Little or no information is provided as to the component and lubricant being tested. Recommendations are therefore generic in nature and may not apply to the current application. Please forward information as to equipment type, reservoir capacity, lubricant type and any pertinent information to allow for a more accurate assessment. Resample at the next service interval to monitor. NOTE: Please provide information regarding reservoir capacity, filter type and micron rating with next sample. Please provide more complete information on your next sample.
