OIL ANALYSIS REPORT

Machine Id
402 CRANE BRIDGE GEARBOX NORTH WEST
 Component
Gearbox
 Fluid
SHELL OMALA S4 GX 220 (24 LTR)

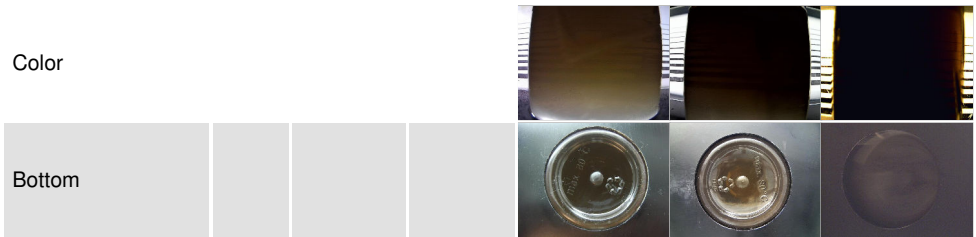
SAMPLE IMAGES	method	limit/base	current	history1	history2
---------------	--------	------------	---------	----------	----------

VISUAL	method	limit/base	current	history1	history2
White Metal	scalar	Visual*	NONE	NONE	NONE
Yellow Metal	scalar	Visual*	NONE	NONE	NONE
Precipitate	scalar	Visual*	NONE	NONE	NONE
Silt	scalar	Visual*	NONE	NONE	NONE
Debris	scalar	Visual*	NONE	NONE	NONE
Sand/Dirt	scalar	Visual*	NONE	LIGHT	NONE
Appearance	scalar	Visual*	NORML	NORML	NORML
Odor	scalar	Visual*	NORML	NORML	NORML
Emulsified Water	scalar	Visual*	>0.2	NEG	NEG
Free Water	scalar	Visual*		NEG	NEG

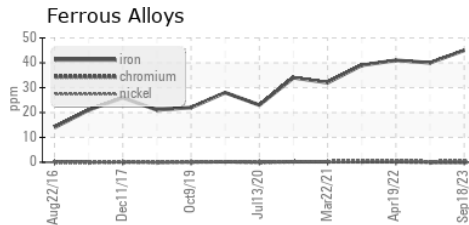
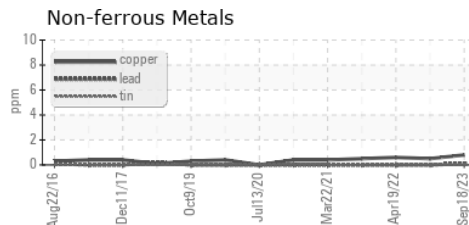
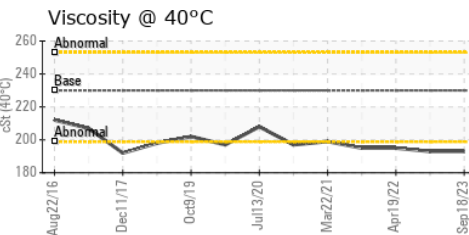
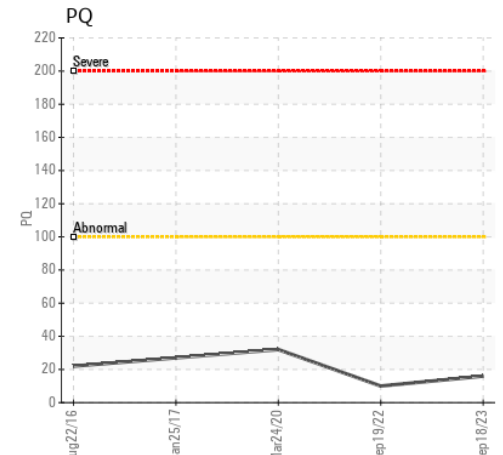
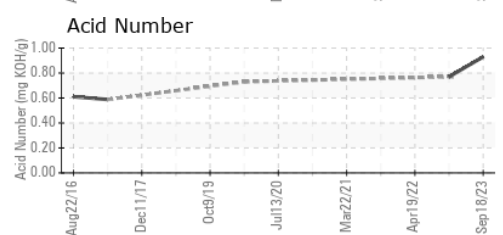
GRAPHS

All component wear rates are normal.

There is no indication of any contamination in the oil.

The AN level is acceptable for this fluid. The condition of the oil is suitable for further service.

Resample at the next service interval to monitor.
