# OIL ANALYSIS REPORT

Area  
**[514279]**  
 Machine Id  
**1933974**  
 Component  
**Unknown Component**  
 Fluid  
**NOT GIVEN (--- GAL)**

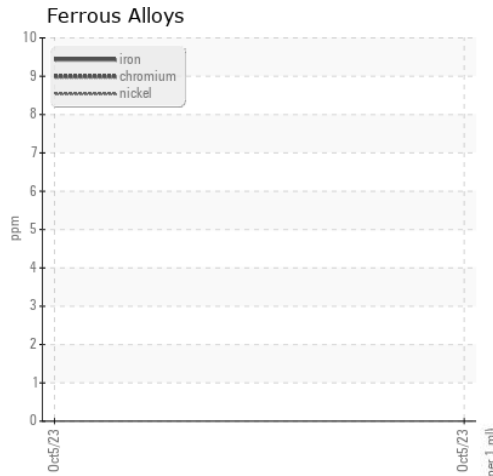
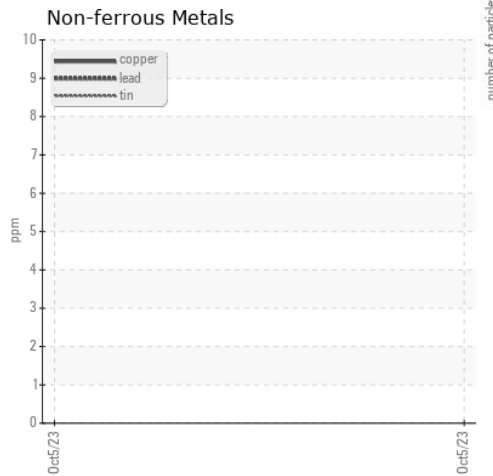
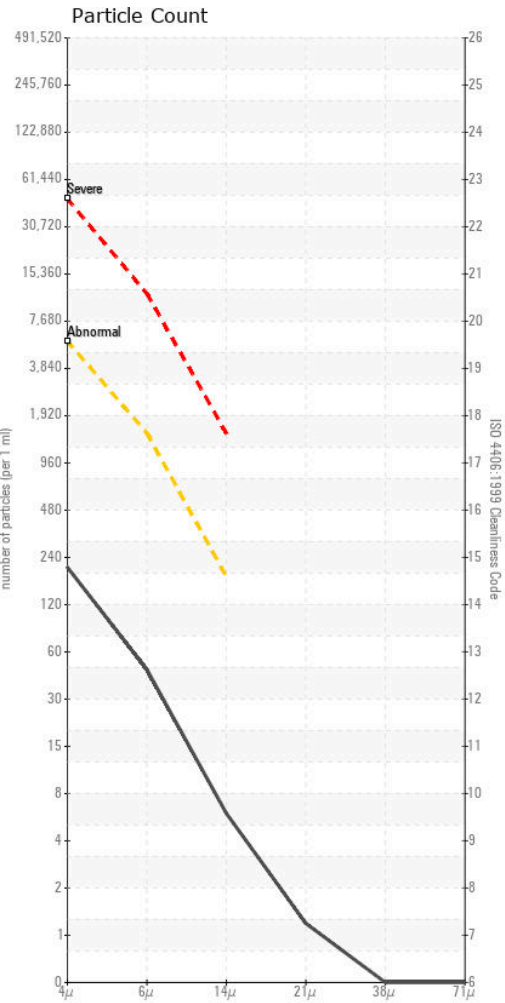
## GRAPHS

ISO Cleanliness Code (ISO 4406:1999): 15/13/10;  
 Cumulative particle counts >4µm = 183, >6µm = 41,  
 >14µm = 5, >21µm = 1, >38µm = 0, >71µm = 0.
