OIL ANALYSIS REPORT

Machine Id
EPIROC MT65 TRK219

Component
Rear Right Planetary

Fluid
PENNZOIL SYNTHETIC SAE 75W140 GL-5 (--- GAL)

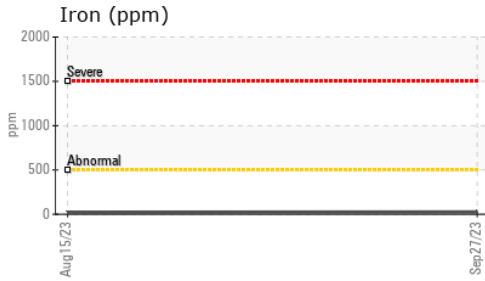
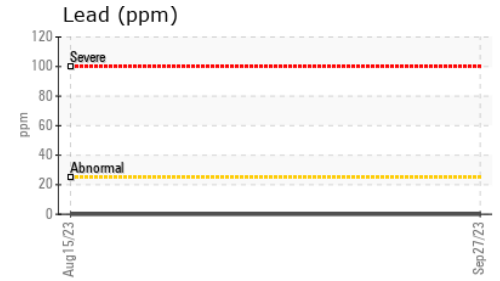
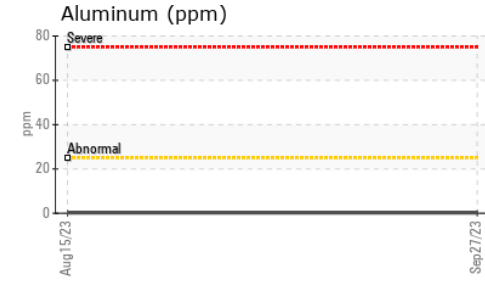
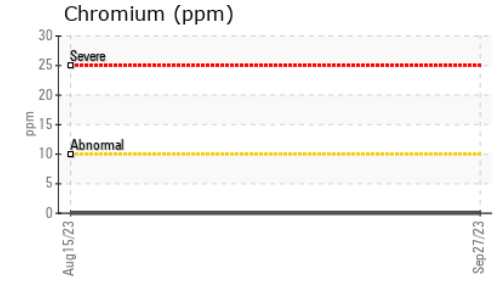
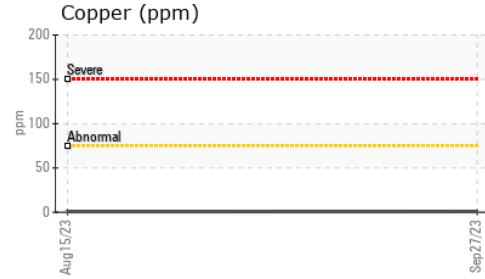
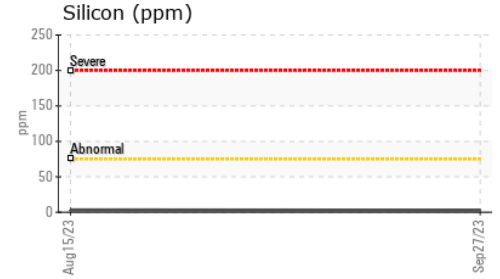
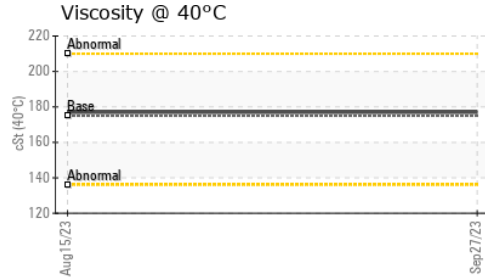
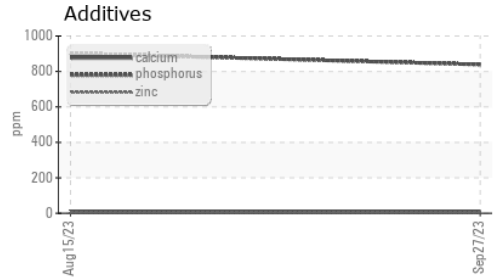
GRAPHS

All component wear rates are normal.

There is no indication of any contamination in the oil.

The condition of the oil is acceptable for the time in service.

Resample at the next service interval to monitor.
