OIL ANALYSIS REPORT

Machine Id
TRK223
 Component
Front Right Planetary
 Fluid
SAE 85W140 (--- GAL)

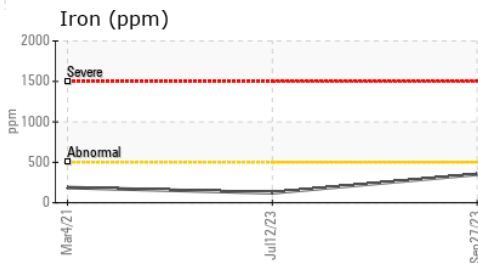
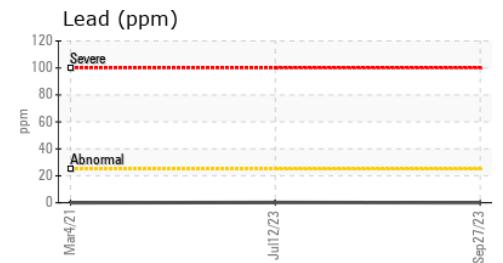
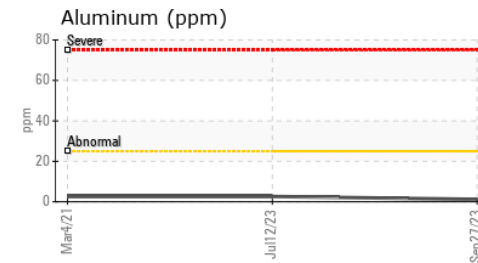
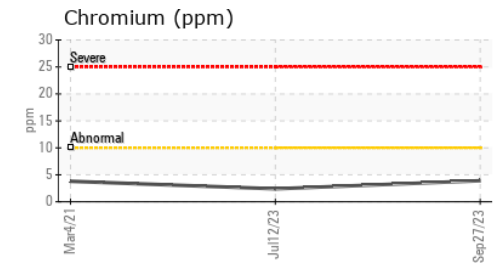
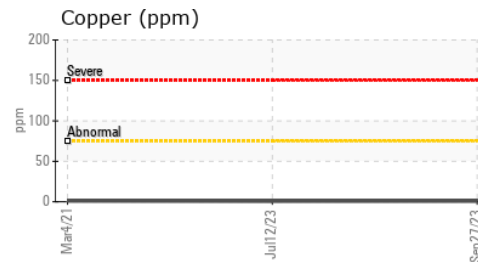
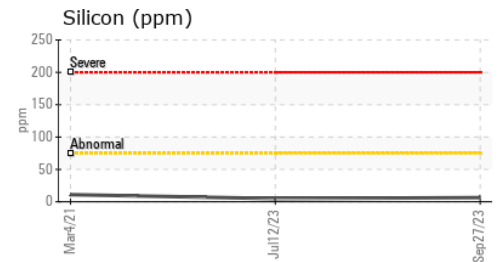
GRAPHS

All component wear rates are normal.

There is no indication of any contamination in the oil.

The condition of the oil is acceptable for the time in service.

Resample at the next service interval to monitor.
 Please specify the component make and model with your next sample.
