OIL ANALYSIS REPORT

Area
OPK/CL05
 Machine Id
101810 Calander

Component
Gearbox
 Fluid
MOBIL MOBILGEAR 600 XP 320 (180 LTR)

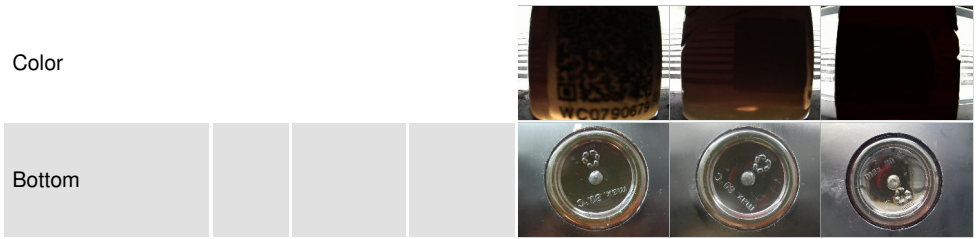
SAMPLE IMAGES	method	limit/base	current	history1	history2
---------------	--------	------------	---------	----------	----------

VISUAL	method	limit/base	current	history1	history2
White Metal	scalar	Visual*	NONE	NONE	NONE
Yellow Metal	scalar	Visual*	NONE	NONE	NONE
Precipitate	scalar	Visual*	NONE	NONE	NONE
Silt	scalar	Visual*	NONE	NONE	NONE
Debris	scalar	Visual*	NONE	NONE	NONE
Sand/Dirt	scalar	Visual*	NONE	NONE	NONE
Appearance	scalar	Visual*	NORML	NORML	NORML
Odor	scalar	Visual*	NORML	NORML	NORML
Emulsified Water	scalar	Visual*	>0.2	NEG	NEG
Free Water	scalar	Visual*		NEG	NEG

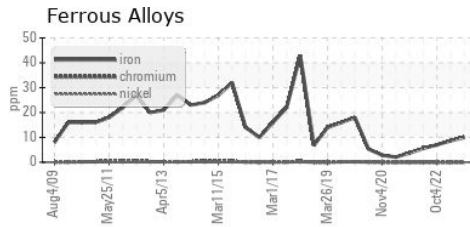
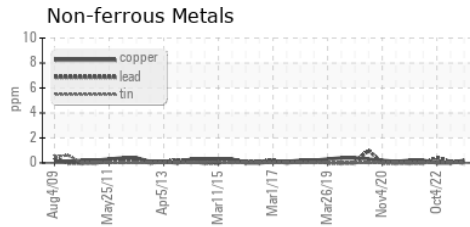
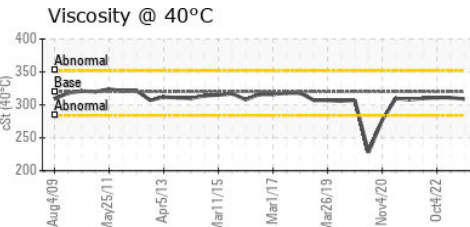
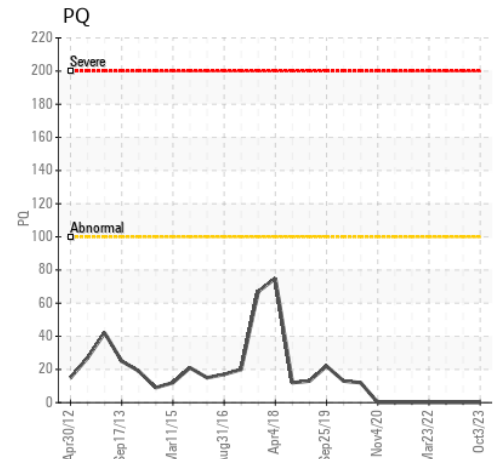
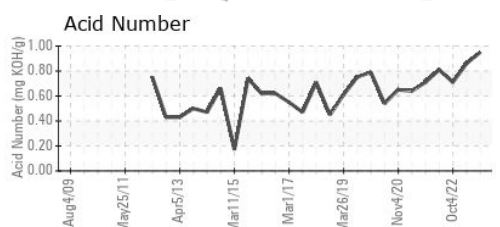
GRAPHS

All component wear rates are normal.

There is no indication of any contamination in the oil.

The AN level is acceptable for this fluid. The condition of the oil is suitable for further service.

Resample at the next service interval to monitor.
