OIL ANALYSIS REPORT

Area
OPK/CL05
 Machine Id
101809 Mill

Component
Gearbox
 Fluid
MOBIL MOBILGEAR 600 XP 320 (80 LTR)

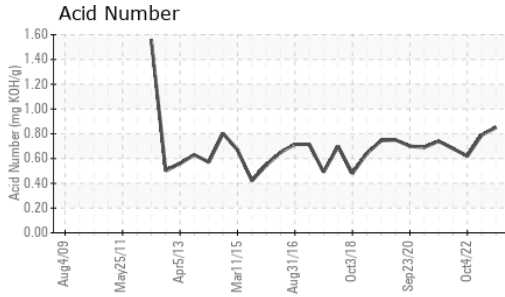
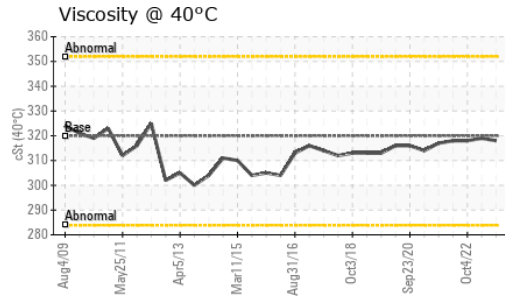
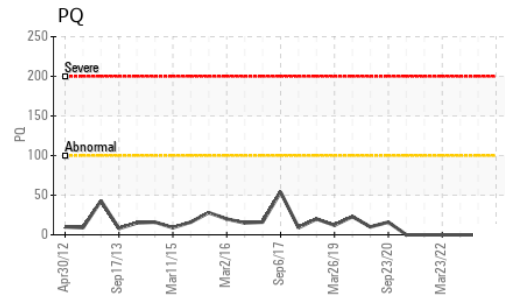
All component wear rates are normal.

There is no indication of any contamination in the oil.

The AN level is acceptable for this fluid. The condition of the oil is suitable for further service.

Resample at the next service interval to monitor.

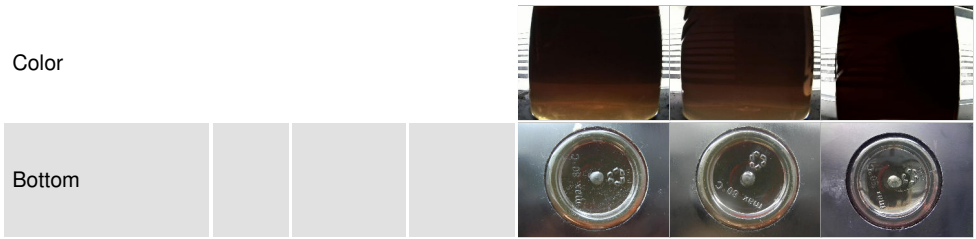
SAMPLE IMAGES	method	limit/base	current	history1	history2
---------------	--------	------------	---------	----------	----------

VISUAL	method	limit/base	current	history1	history2
White Metal	scalar	Visual*	NONE	NONE	VLITE
Yellow Metal	scalar	Visual*	NONE	NONE	NONE
Precipitate	scalar	Visual*	NONE	NONE	NONE
Silt	scalar	Visual*	NONE	NONE	NONE
Debris	scalar	Visual*	NONE	NONE	NONE
Sand/Dirt	scalar	Visual*	NONE	NONE	NONE
Appearance	scalar	Visual*	NORML	NORML	NORML
Odor	scalar	Visual*	NORML	NORML	NORML
Emulsified Water	scalar	Visual*	>0.2	NEG	NEG
Free Water	scalar	Visual*		NEG	NEG
