OIL ANALYSIS REPORT

Area
SAB2
 Machine Id
SAB2 G21

Component
Middle Guide Bearing
 Fluid
ESSO TERESSO ISO 46 (364 LTR)

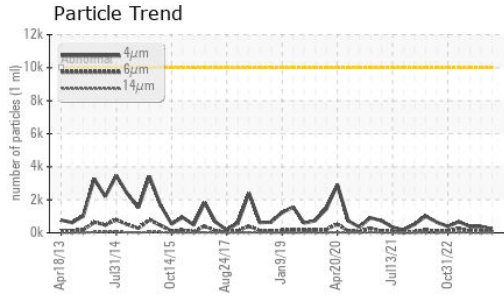
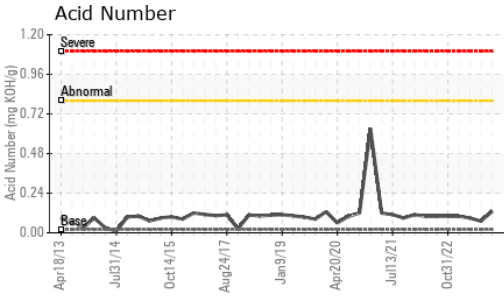
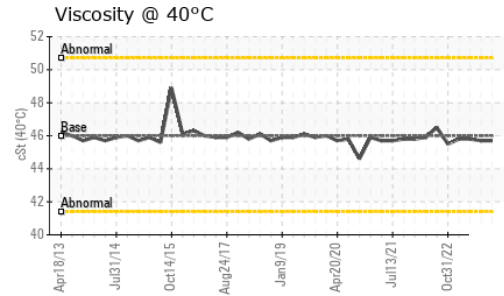
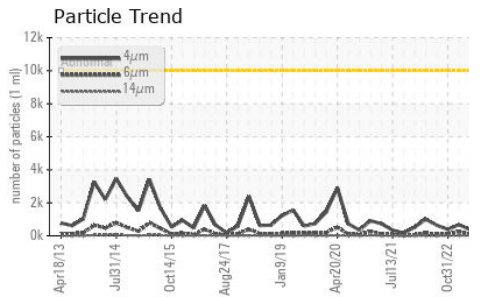
All component wear rates are normal.

The system cleanliness is acceptable for your target ISO 4406 cleanliness code. The system and fluid cleanliness is acceptable.

The AN level is acceptable for this fluid. The condition of the oil is suitable for further service.

Resample at the next service interval to monitor.

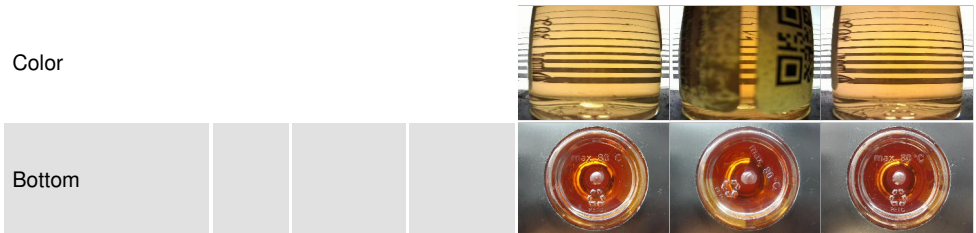
SAMPLE IMAGES	method	limit/base	current	history1	history2
---------------	--------	------------	---------	----------	----------

VISUAL	method	limit/base	current	history1	history2
White Metal	scalar	Visual*	NONE	NONE	NONE
Yellow Metal	scalar	Visual*	NONE	NONE	NONE
Precipitate	scalar	Visual*	NONE	NONE	NONE
Silt	scalar	Visual*	NONE	NONE	NONE
Debris	scalar	Visual*	NONE	NONE	NONE
Sand/Dirt	scalar	Visual*	NONE	NONE	NONE
Appearance	scalar	Visual*	NORML	NORML	NORML
Odor	scalar	Visual*	NORML	NORML	NORML
Emulsified Water	scalar	Visual*	>2	NEG	NEG
Free Water	scalar	Visual*		NEG	NEG
