Customer Id: ONTQUE
 Sample No.: WC0858087
 Lab Number: 02592128
 Test Package: IND 2

OIL ANALYSIS REPORT

Area
SAB2
Machine Id
SAB2 G19

Component
Thrust Bearing
Fluid
ESSO TERESSO ISO 46 (3182 LTR)

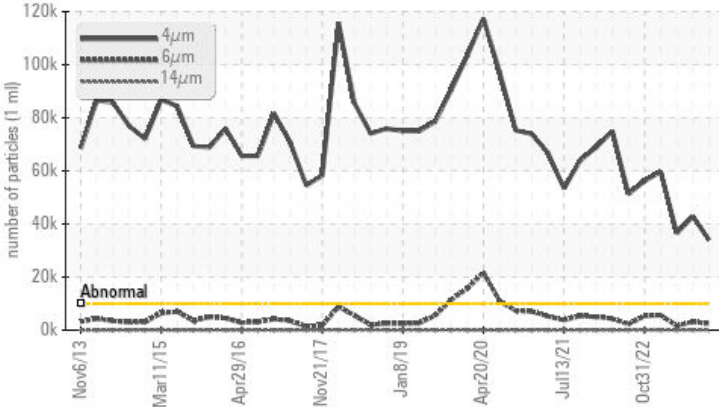
▲ Particle Trend

Sample Status			ABNORMAL	ABNORMAL	ABNORMAL
Particles >4µm	ASTM D7647	>10000	▲ 33994	▲ 42855	▲ 36519
Particles >6µm	ASTM D7647	>1300	▲ 2452	▲ 3151	▲ 1626
Oil Cleanliness	ISO 4406 (c)	>20/17/14	▲ 22/18/11	▲ 23/19/12	▲ 22/18/10

We recommend you service the filters on this component. We recommend an early resample to monitor this condition. Please contact your representative for information regarding the proper sampling kits for your service. NOTE: We recommend using IND 3 test kits, this testkit includes Analytical Ferrography which provides a detailed morphological analysis of wear particles present in the fluid.

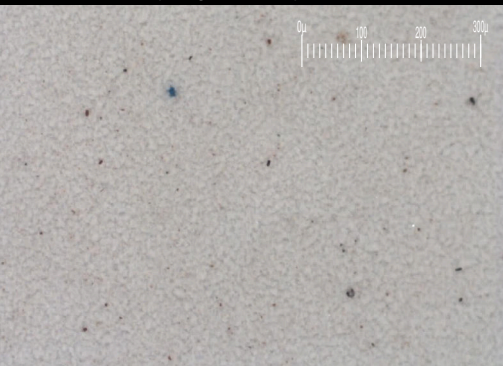
Particle Filter (Magn: 100 x)

There is a moderate amount of silt (particulates < 14 microns in size) present in the oil. The system cleanliness is above the acceptable limit for the target ISO 4406 cleanliness code.

We recommend you service the filters on this component. We recommend an early resample to monitor this condition. Please contact your representative for information regarding the proper sampling kits for your service. NOTE: We recommend using IND 3 test kits, this testkit includes Analytical Ferrography which provides a detailed morphological analysis of wear particles present in the fluid.
