# OIL ANALYSIS REPORT

Machine Id  
**A-BURG LADDER L-1**  
 Component  
**Hydraulic System**  
 Fluid  
**ESSO ATF DEXTRONIII /MERCON (--- GAL)**

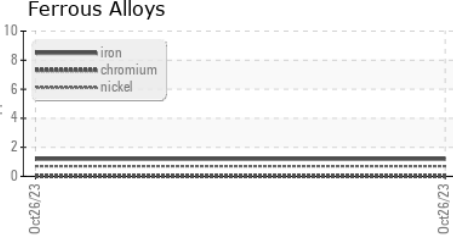
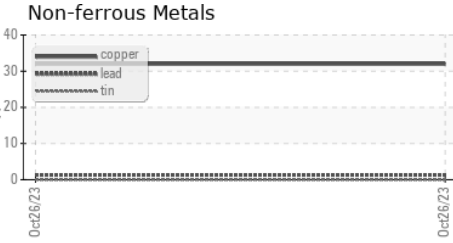
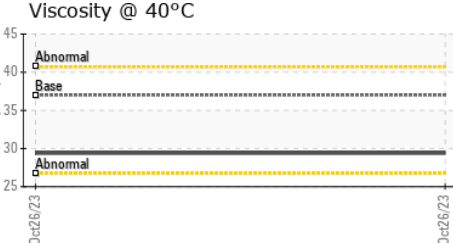
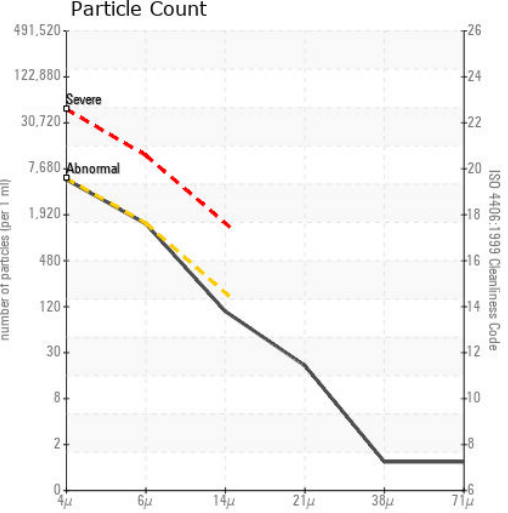
## GRAPHS

All component wear rates are normal.

The system cleanliness is acceptable for your target ISO 4406 cleanliness code. The system and fluid cleanliness is acceptable.

Additive levels indicate the addition of a different brand, or type of oil. The condition of the oil is acceptable for the time in service.

Confirm the source of the lubricant being utilized for top-up/fill. Resample at the next service interval to monitor. Please specify the component make and model with your next sample.
