OIL ANALYSIS REPORT

Machine Id
146
 Component
Rear Transmission (Auto)
 Fluid
CASTROL TRANSYND (--- LTR)

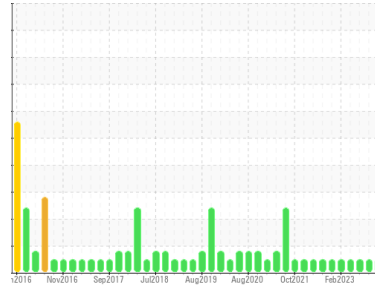
Sample Rating Trend

NORMAL

All component wear rates are normal.

There is no indication of any contamination in the fluid.

The condition of the fluid is acceptable for the time in service.

Resample at the next service interval to monitor.
