OIL ANALYSIS REPORT

Machine Id
Pioneer GEN2TRANSFORMER (S/N 616458-1)

Component
Transformer Oil

Fluid
TRANSFORMER MINERAL API II (2260 LTR)

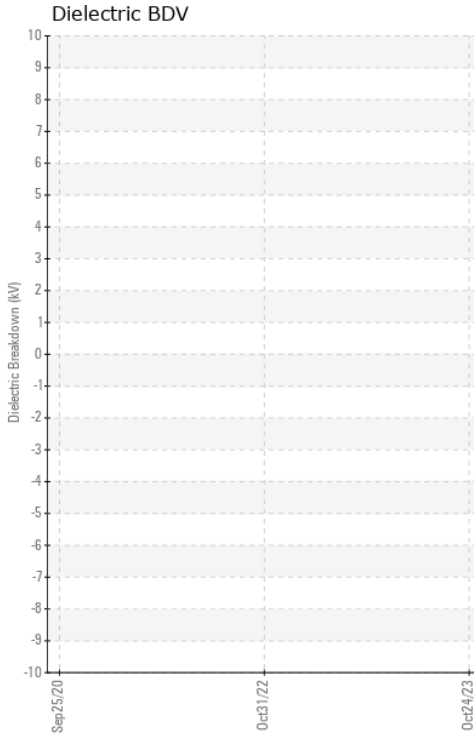
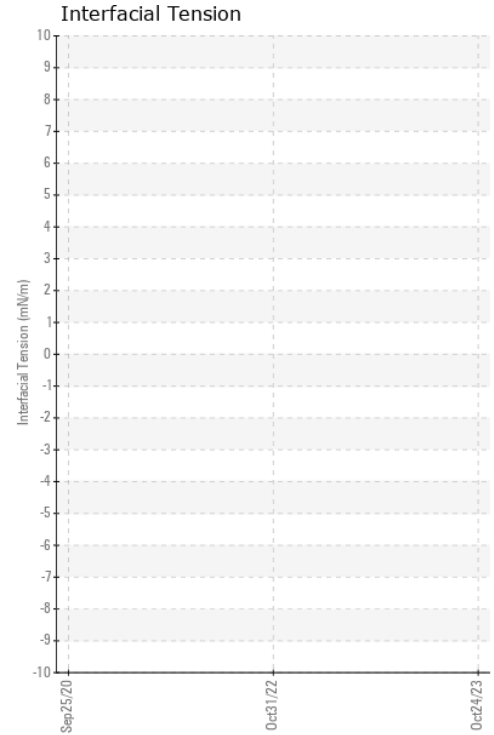
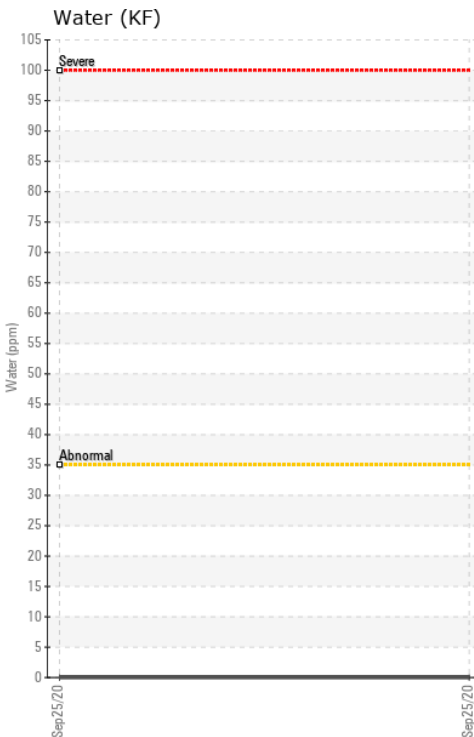
GRAPHS

Carbon Monoxide >=350 (0.035%), Carbon Dioxide >=2500 (0.25%): Thermal decomposition of cellulose.

method	limit/base	current	history1	history2
DGA - H2	ppm	5	5	3
DGA - O2	ppm	8677	10368	15144
DGA - N2	ppm	69590	48092	82392
DGA - CO	ppm	▲ 819	▲ 679	▲ 652
DGA - CO2	ppm	▲ 5400	▲ 4662	▲ 4153
DGA - Methane	ppm	10	10	9
DGA - Acetylene	ppm	0	0	0
DGA - Ethylene	ppm	8	14	6
DGA - Ethane	ppm	1	1	0
DGA - Total Gas Content	%	84510	63831	102359
DGA - Total Combustible Gas	ppm	843	709	670

We recommend an early resample to monitor this condition. No other corrective action is recommended at this time. Diagnostician`s Note: Syringe only received, no sample bottle received so standard testing (IFT, acidity, dielectric, power factor) could not be tested.
