Customer Id: CARGUE
 Sample No.: WC0882212
 Lab Number: 02601062
 Test Package: IND 2

OIL ANALYSIS REPORT

Area
Hydraulic System in Plant [412789629]
 Machine Id
Hock Cutter #1 - Maximo #6139 - 1000029254
 Component
Hydraulic System
 Fluid
TOTAL FINA NEVASTANE FG AW 46 (10 GAL)

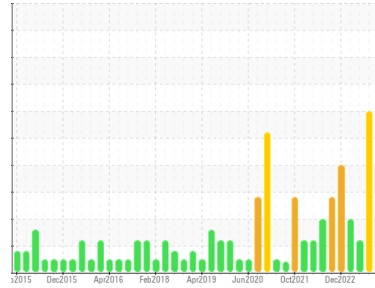
Sample Rating Trend

Sample Status			SEVERE	SEVERE	ABNORMAL
Particles >4µm	ASTM D7647	>5000	🔴 138717	🔴 70357	🟡 13371
Particles >6µm	ASTM D7647	>1300	🔴 49256	🔴 14549	🟡 1519
Particles >14µm	ASTM D7647	>160	🟡 388	🟡 1167	92
Oil Cleanliness	ISO 4406 (c)	>19/17/14	🔴 24/23/16	🔴 23/21/17	🟡 21/18/14

Check seals and/or filters for points of contaminant entry. The air breather requires service. If unrated, we recommend that you replace with a suitable micron rated and/or desiccant air breather. If rated, we recommend that you service/replace the breather. We recommend you service the filters on this component. Resample in 30-45 days to monitor this situation.

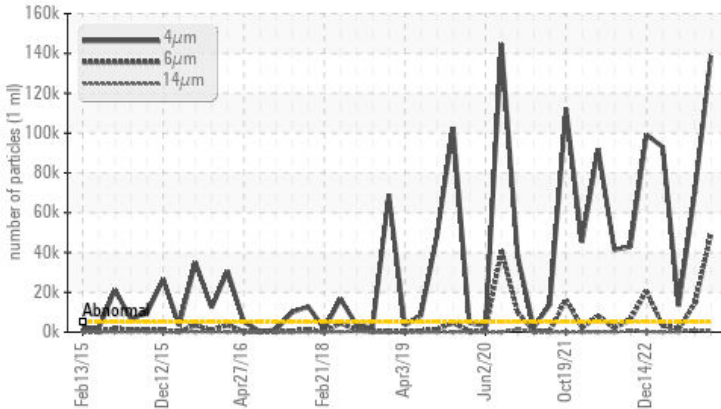
Particle Trend

There is a high amount of silt (particulates < 14 microns in size) present in the oil.

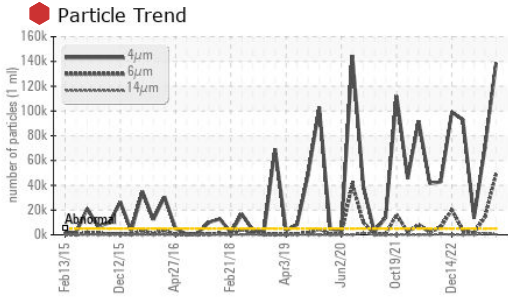
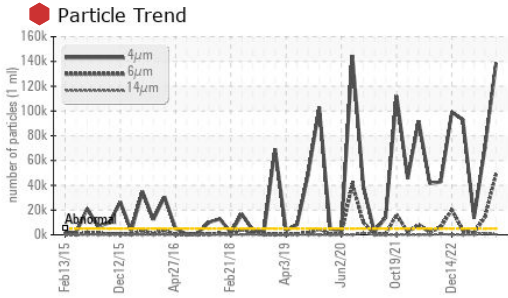
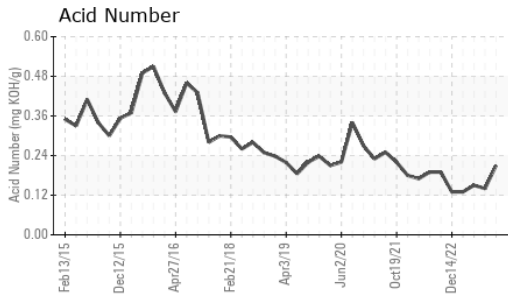
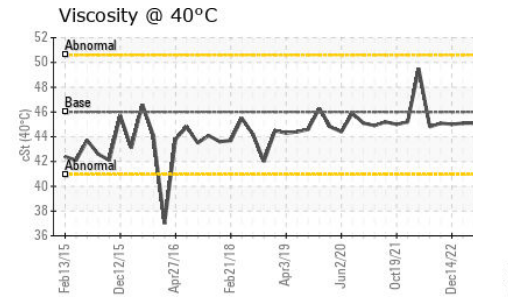
method	limit/base	current	history1	history2
Particles >4µm	ASTM D7647	>5000	138717	70357	13371
Particles >6µm	ASTM D7647	>1300	49256	14549	1519
Particles >14µm	ASTM D7647	>160	388	1167	92
Particles >21µm	ASTM D7647	>40	27	346	31
Particles >38µm	ASTM D7647	>10	0	11	2
Particles >71µm	ASTM D7647	>3	0	0	0
Oil Cleanliness	ISO 4406 (c)	>19/17/14	24/23/16	23/21/17	21/18/14
