# **OIL ANALYSIS REPORT**

# VOLVO L120F LDR010

Component Hydraulic System

AW HYDRAULIC OIL ISO 32 (-

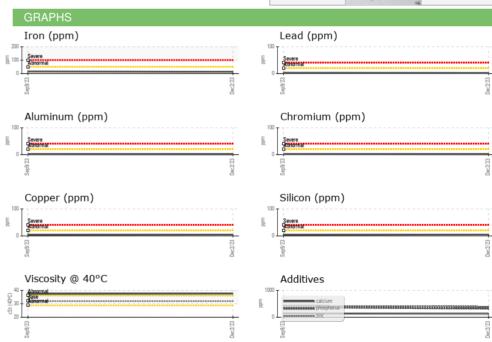
Visc @ 40°C

The condition of the oil is acceptable for the time in service.

37.6

37.4

Resample at the next service interval to monitor. Please contact your representative for information regarding the proper sampling kits for your service. NOTE: We recommend using MOB 2 test kits, this testkit includes Particle Count to determine the ISO cleanliness of the fluid.
